City of Leadville, CO

# Central Leadville Conditions Survey

26 October 2017

Leadville Urban Renewal Authority (LURA)

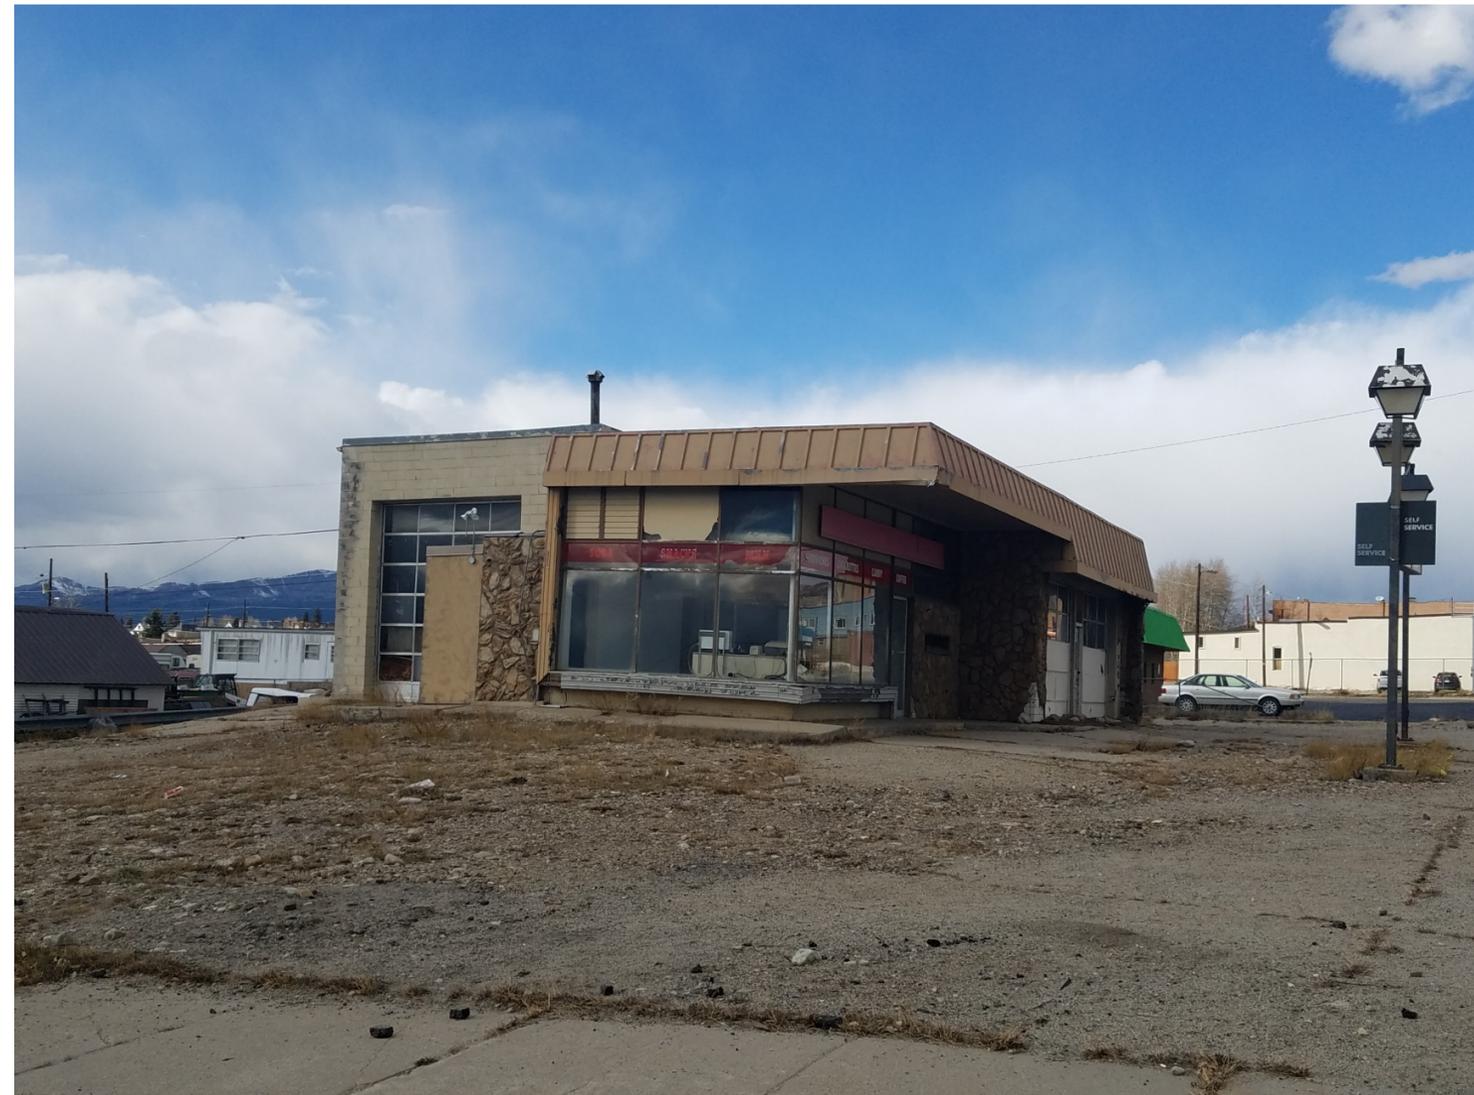
## a. Slum, Deteriorated, or Deteriorating Structures

Numerous properties, both occupied and abandoned, exhibited visible damage to the items identified above.

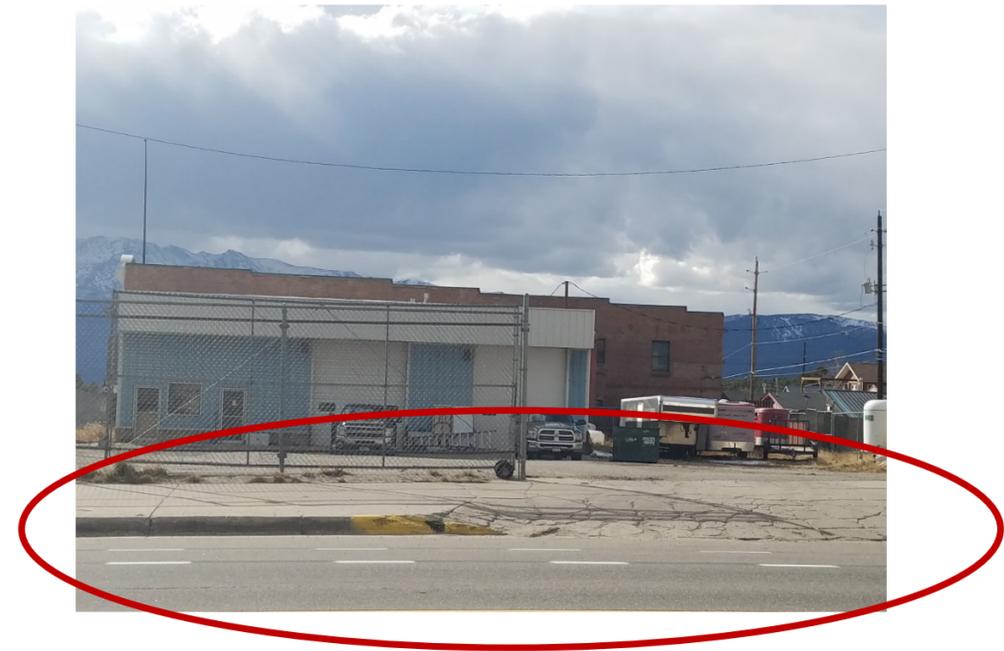
## b. Predominance of Defective or Inadequate Street Layout

Numerous instances of roadway conditions, including a lack of appropriate accommodations for safe vehicular and non-vehicular movement, and deteriorating infrastructure, were both visible and confirmed by discussions with local officials.

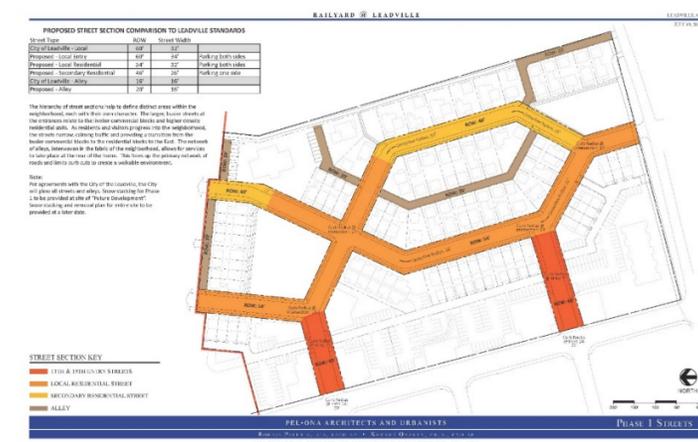
Railyard Property Proposed Street Plan

A lack of roads within large parcels has also been determined to contribute to unsafe conditions.

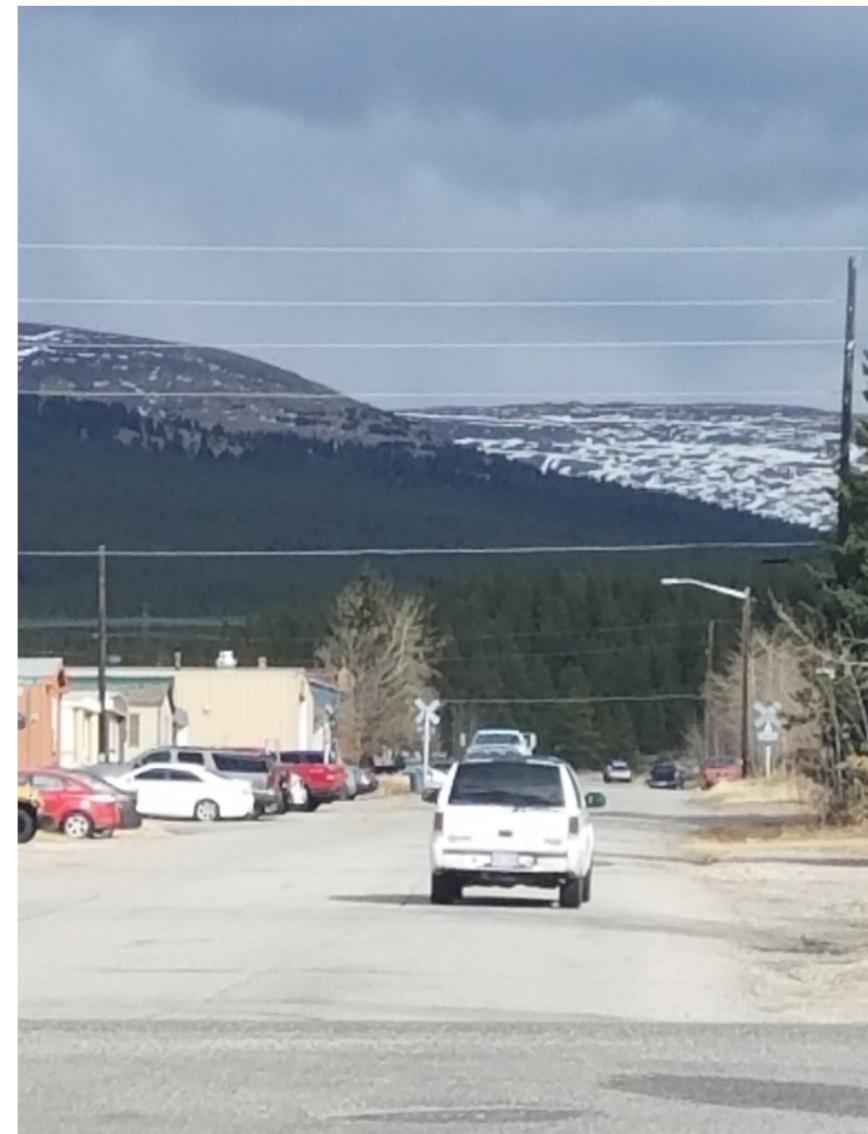
## c. Faulty Lot Layout in Relation to Size, Adequacy, Accessibility, or Usefulness

A review of parcel lines visible from aerial photography illustrates numerous parcels which are irregular in shape, particularly among those located beyond the major corridors bisecting the Area, and likely the result of past property subdivision filings.

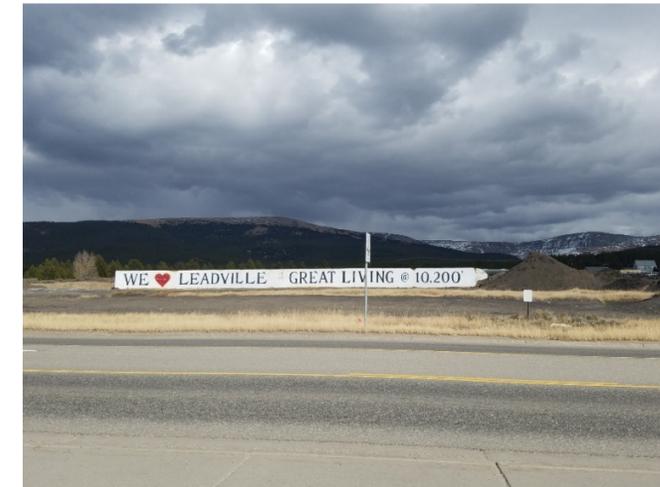
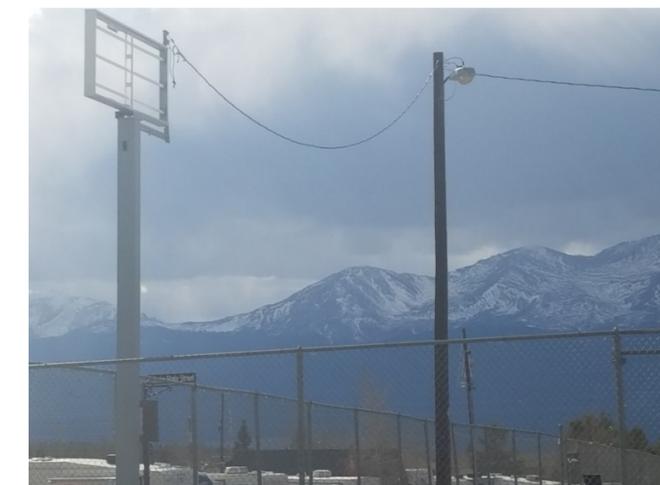
## e. Deteriorating Site or Other Improvements

Abandoned and degraded signs are obvious throughout the Survey Area, primarily along the major roadway corridors that bi-sect the major Survey Area segments.

Several vacant commercial properties located along Harrison Street appear abandoned and neglected, with overgrown weeds, cracked pavement, and accumulating trash and debris visible.

Few commercial properties have landscaping, and several of those with landscaping elements are adequately maintained.

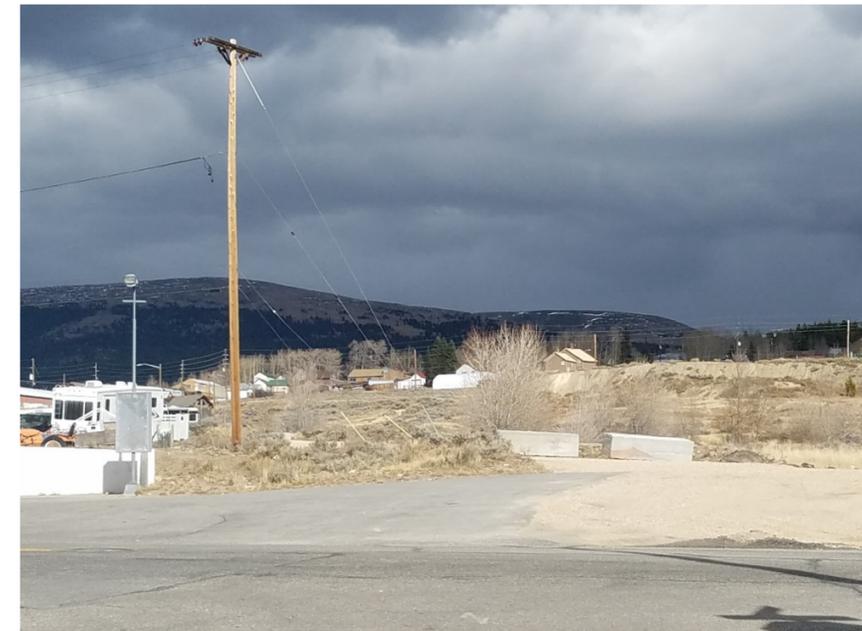
## f. Unusual Topography or Inadequate Public Improvements or Utilities

In addition to overhead utilities present throughout the Survey Area, and absence of pedestrian and bicycle accommodations, there is inadequate lighting to allow for a safe walking environment. According to surveys completed by the owners of the Railyard Property, as well as discussions with representatives of the City, existing infrastructure and utilities serving the Area will require improvements including upsizing and material replacement, in order to meet the requirements of new development and redevelopment projects.

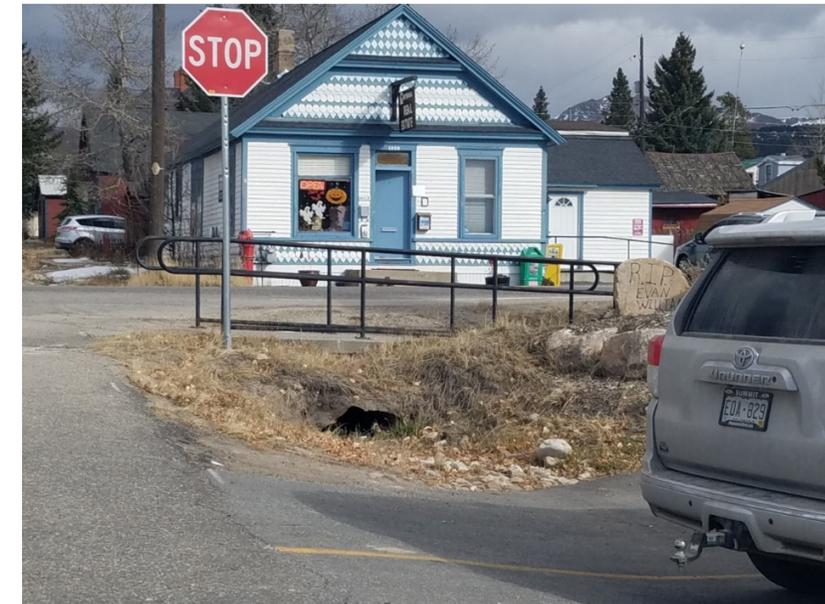
## h. Existence of Conditions that Endanger Life or Property by Fire or Other Causes

Visible circumstances contributing to unsafe and unhealthy conditions primarily include those identified in the context of other factors including abandoned structures left in disrepair and inadequate infrastructure for non-vehicular mobility. Also posing a threat to property and people is the presence of environmental contaminants within the Railyard Property and a lack of appropriate protections from fire. In a letter provided by the Leadville Fire Marshal on 31 October 2017, there are several businesses and apartments located along Harrison Street in need of improvements that will make them fire code compliant. In addition, among those businesses which maintain a smoke detector, they are primarily located within the store area; meaning, if a detector activates it will only alert the occupants present in the building at the time, and no notification sent to the Lake County Dispatch.

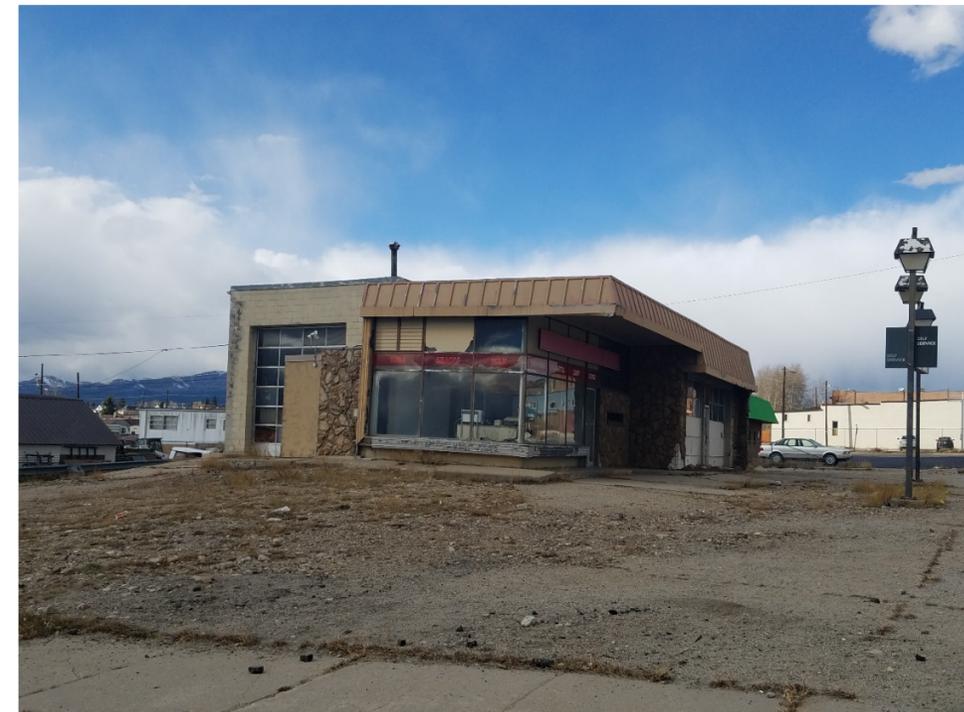
## k.5. High Service Requirements or Substantial Physical Under-Utilization

There are numerous instances of both vacant and abandoned properties and buildings throughout the Survey Area. Efforts to protect pedestrians range from wire fencing to remnant infrastructure (roadway barriers), yet several offer no protections.
