Leadville Historic Resources Survey: Phase 1

August 2017

Three Gables Preservation
Deon Wolfenbarger

Harrison Avenue

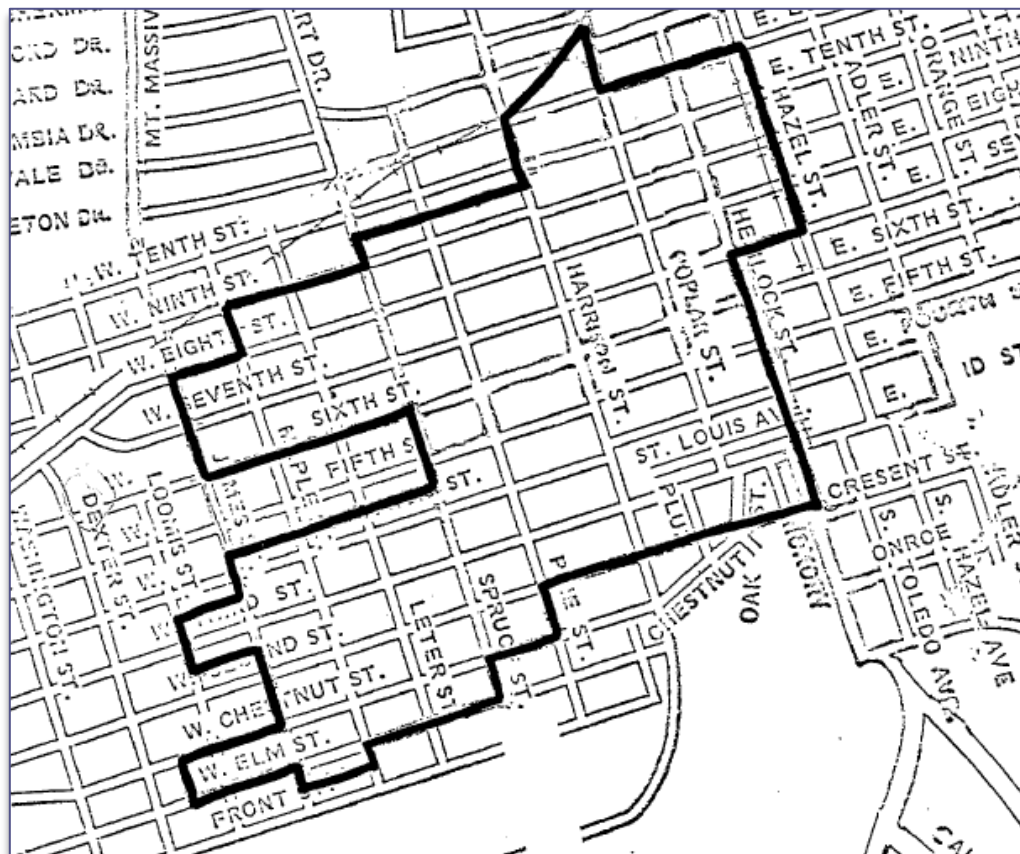
Leadville's National Historic Landmark District boundaries, 1968.

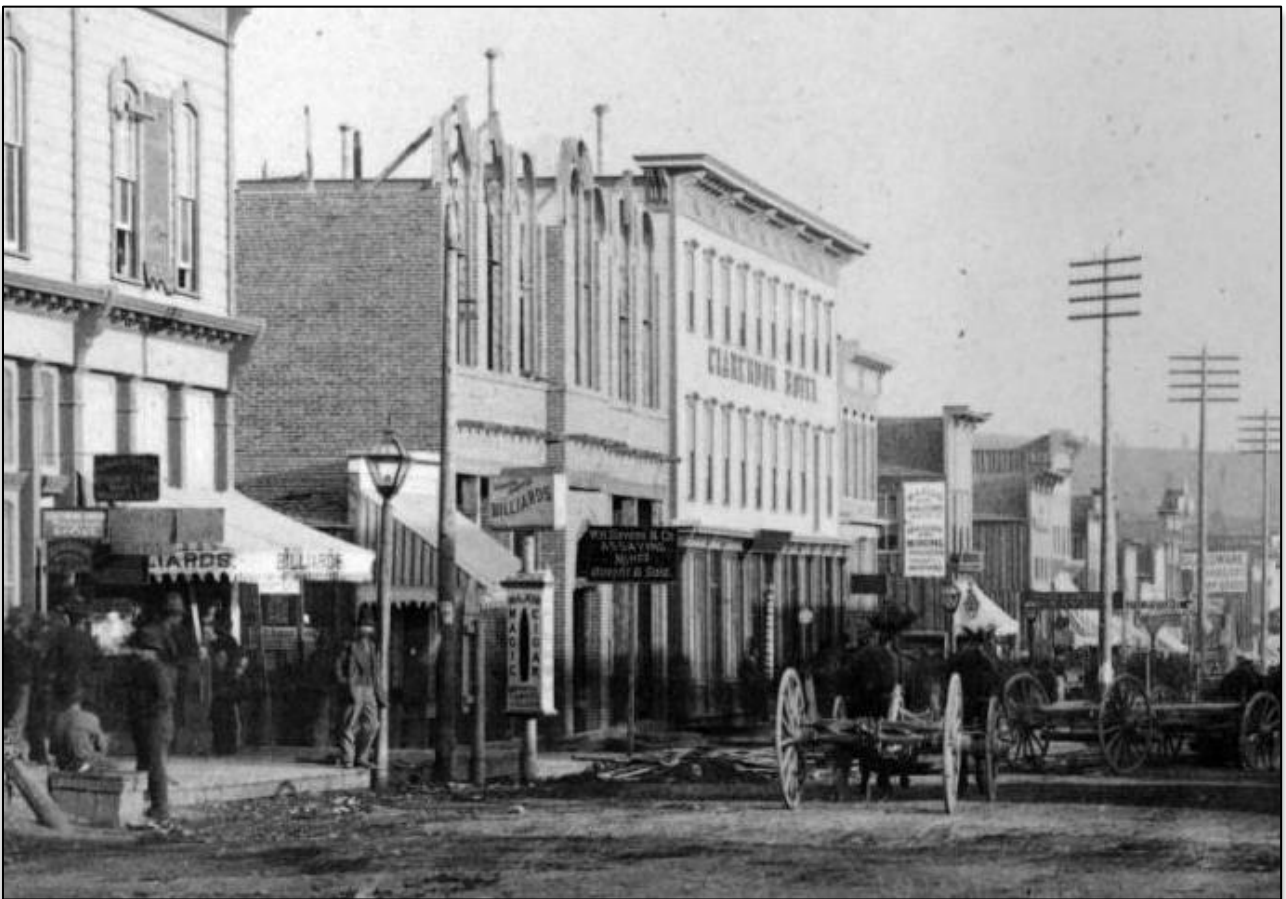
1879, Tabor Opera House under construction. The Clarendon House hotel is on the right, and frame commercial buildings extend south to Chestnut Street. *Source:* George D. Wakely, X-6370, Denver Public Library Digital Collections.

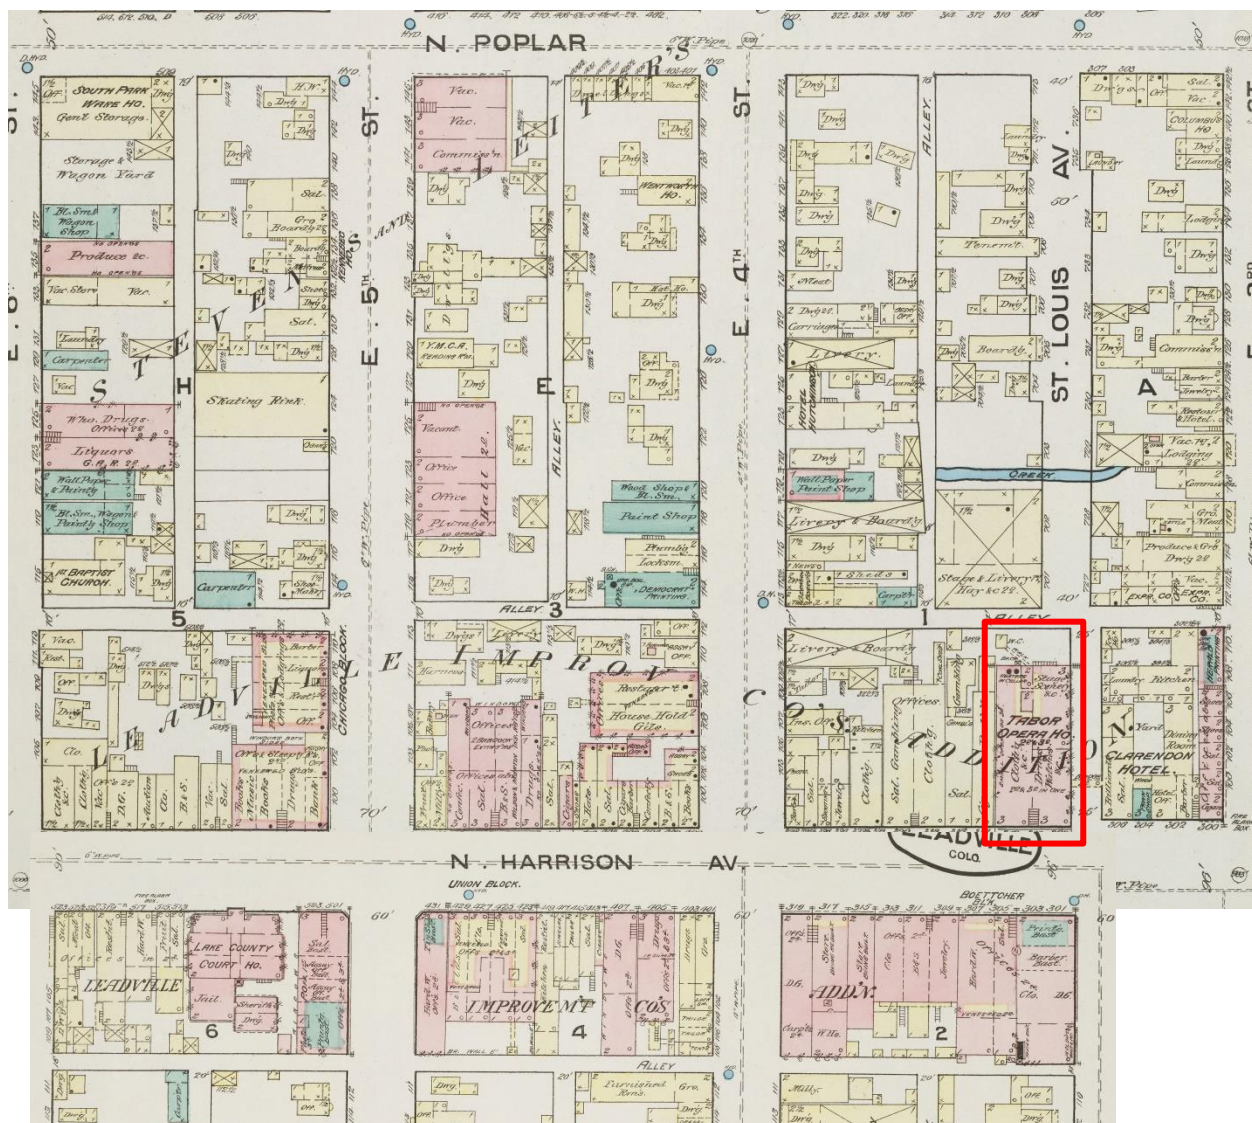
Harrison Avenue in 1883, between E. 3rd Street (left) and E. 6th Street (right)

The map above shows Harrison Avenue between 3rd and 6th Streets in 1883. The Tabor Opera House was constructed in 1879 on a block that already contained frame commercial buildings. Its construction spurred commercial growth on the north (left side of map) as well as east up along the adjoining blocks of E. 4th, 5th and 6th streets. While there are a number of saloons here, the percentage is much lower than on Chestnut and State streets. There is also a large number of brick buildings in this area, showing that by 1883, Harrison Avenue had become the prime and more desirable commercial thoroughfare in town. The construction of the Lake County Courthouse in 1880 sealed the fate of Harrison Avenue. Designed by George E. King, architect, it was the most imposing building in Leadville. With details from both the Beaux Arts and Second Empire styles, the brick building featured polished granite details. However, the

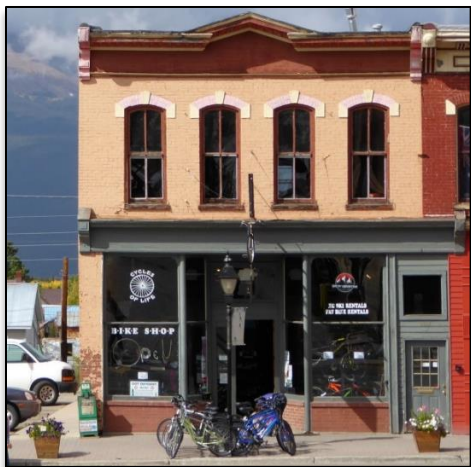
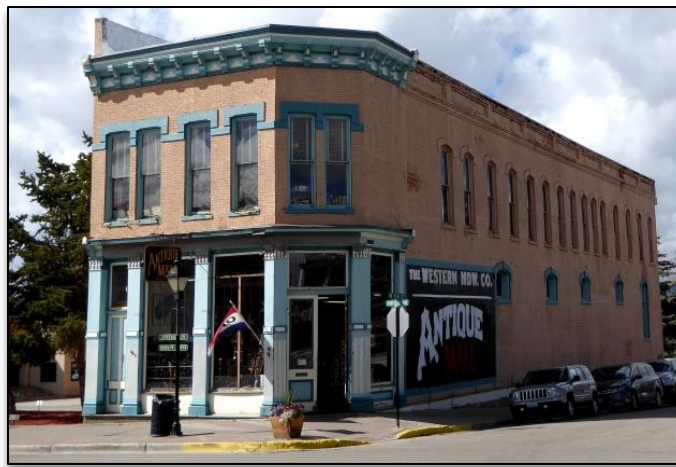
Left: Part of the 1878 Bush-Trimble Block. Right: Manville & McCarthy's Hardware store (1881)

The Bush-Trimble Block (5LK.40.2, built 1878) at 309 Harrison Avenue and Manville & McCarthy's Hardware (5LK.40.5, built 1881) store at 431 Harrison Avenue are examples of the masonry Victorian era commercial buildings constructed during this period. This second wave of commercial buildings were usually constructed of brick, and replaced the initial round of frame buildings from the late 1870s and early 1880s, primarily on the south end of Harrison Avenue. While it is not unusual for historic downtowns in the West to experience this transition, what was different about Leadville was the speed in which this occurred. Some frame commercial buildings lasted only a few years before they were replaced with these more permanent representations of the town's prosperity. The Manville & McCarthy Hardware store was the second building constructed for this firm. Their first store was on Chestnut Street, but having outgrown that location, they constructed a new \$15,000 building on Harrison known as their "Upper Store." Construction began on the new building in mid-August 1881, and a local newspaper reported that:

The main wareroom is 125 feet long by 24 feet clear inside, iron and plate-glass front, the ceiling 20 feet high, a basement under the entire building and extending under the sidewalks, together with the rooms of the Leadville Mining club, occupying the second store, constitute, the building . . . The structure is substantially built of brick, and finished in keeping with its stability. . .³

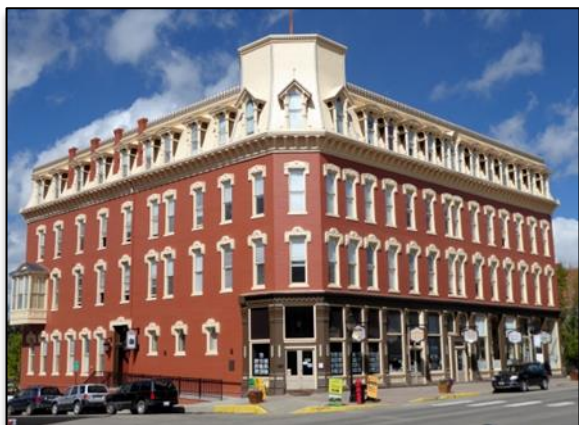
Stability was an important feature of Leadville's brick commercial buildings, which served as physical manifestations of the town's transition from mining camp to a true city. Both residential and commercial growth continued at a fast pace during the 1880s, and Leadville became the second largest city in Colorado as well as the fastest growing. By the mid-1880s, buildings associated with an established town were constructed, such as hospitals, fire departments, and opera houses. The construction of the Tabor Grand Hotel (left, 5LK.40.13) at 701 Harrison Avenue was the result of a

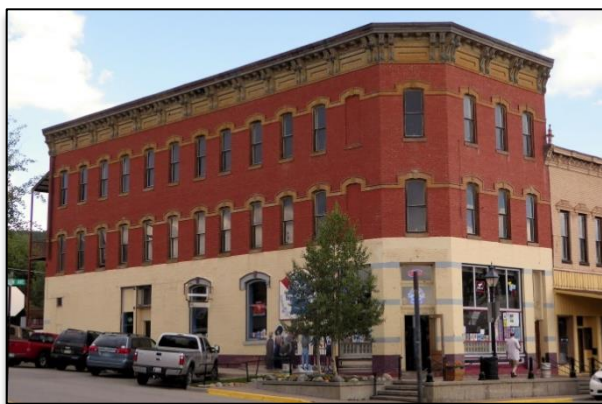
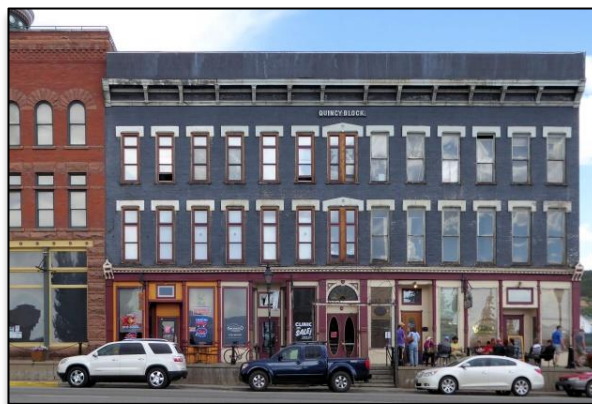
Large corner buildings that spanned several lots were features of commercial construction in this period; some of these were financed by the earnings from mining, while others were built purely as real estate investments. The Breene Block at 326 Harrison Avenue (left, 5LK.40.22) and the Quincy Block at 414-420 Harrison (right, 5LK.40.23) were both constructed in the 1880s. Like several businessmen in Leadville, Peter Breene came to Leadville in 1877 and acquired a fortune in mining. Also prominent in state politics, Breene used this fortune to pay for the construction of his commercial building. As the *Carbonate Chronicle* noted, "Lieutenant-Governor Breene has purchased one of the most eligible corner lots in Leadville, upon which he intends erecting a fine business block. We have an idea Mr. Breene will find this more profitable and satisfactory than politics or states craft. Men make few enemies by building monuments of this character." J. Warren Faxon built the Quincy Block a few lots north of the Breene Block. Unlike Breene, Faxon moved to Leadville solely for its real estate opportunities. He moved to town in the summer of 1879 where he established himself as a realtor. That same year, he supervised the construction of the Boston Block building (demolished) just south of the Quincy Block. He hired Denver architect Frank E. Edbrooke to design his new brick Quincy Block building.

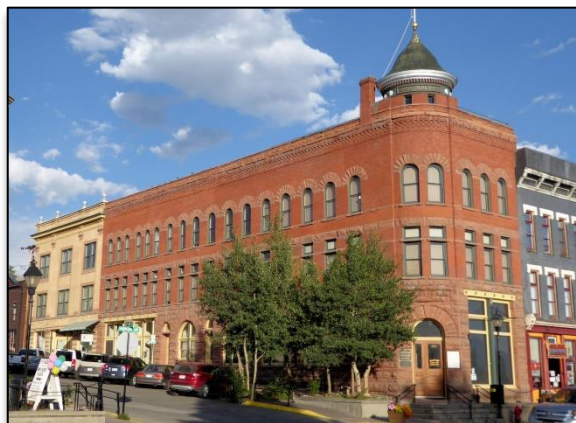
The American National Bank Building at 460 Harrison Avenue (5LK.40.24) was one of the last large commercial block buildings constructed prior to the crash of 1893. The company first opened in the Breene Block on January 7, 1889. While the Breene Block was in a desirable location, the directors wanted their own property upon which they could build. In early April 1891, President Morgan Williams announced plans to construct a three-story brick and sandstone business block building on the southeast corner of Harrison Avenue and Fifth Street. The building, financed by James Dexter, extended twenty-five feet along Harrison

Avenue, and 110 feet along E. Fifth Street. It was surmounted with a red sandstone 17’ tower. The bank occupied the first floor, and the second and third floors were divided into offices, “each of which had a lavatory.” The building had steam heat and electricity when it opened.

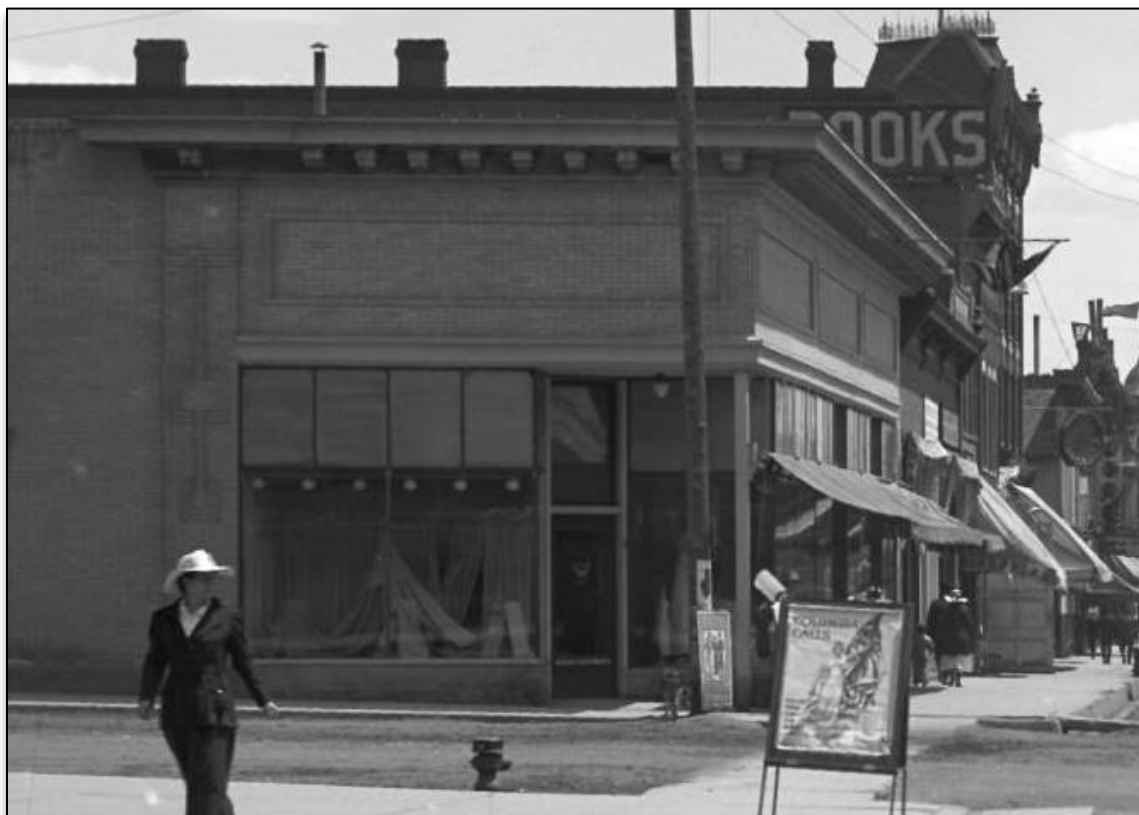
714-716 Harrison (5LK.40.36). 1918. *Source:* GB-8324, George L. Beam, DPL Digital Online Collection.

A new commercial form came to Harrison Avenue during this period – the one-part commercial block. In part, this reflected the strain on the pocketbooks of Leadville merchants. There was less money available to build the elaborate two-story brick buildings with highly detailed architectural flourishes. Prevalent across the United States, the facades of these one-story buildings were devoted to the display window, leaving little room for architectural details. Thus the small cornice at the top remained the only area available for embellishment. The more elaborate of the two examples built on Harrison Avenue in this period is the Hart-Zaitz Mercantile Building at 714-716 Harrison (below, 5LK.40.36). Here the widely overhanging metal cornice is very similar to those constructed in the late

Victorian period of Leadville. The Jos. Harwitz Building (5LK.40.58) on the left, however, used brickwork to emulate the cornices of the previous decades.

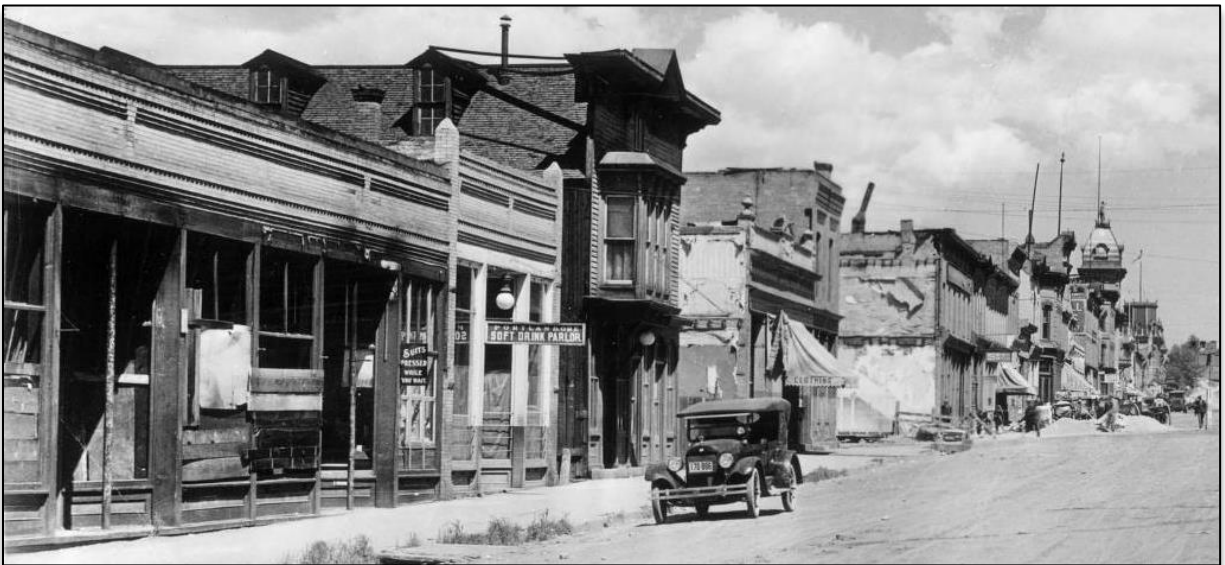
1924. The south end of Harrison Avenue shows the effects of the collapse of the mining economy, with soft drink parlors scattered among the vacant and demolished buildings. Harrison Avenue is still a dirt road at this point.

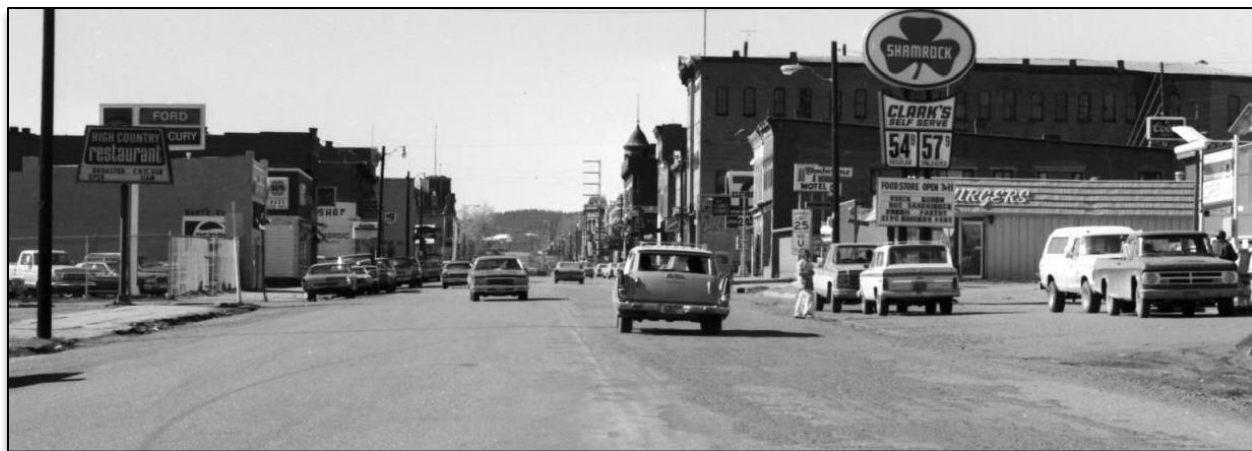
The south end of Harrison Avenue in 1978, showing the effects of the automobile economy.
Source: X-461, DPL digital online photographs.

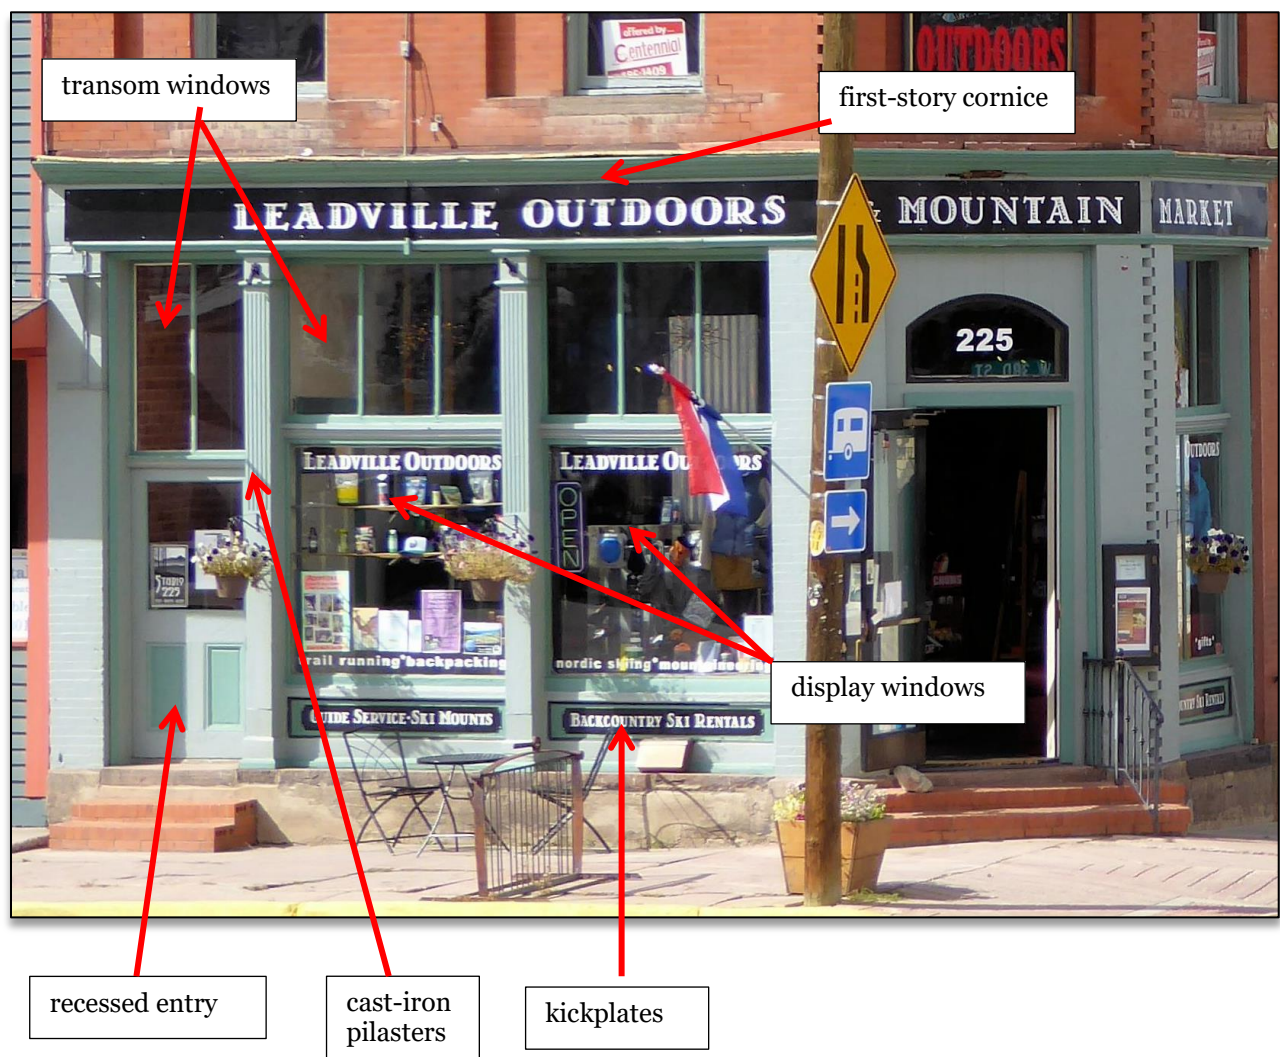
Besides the distinction between the first and second story, the arrangement of the storefront facade of the two-part commercial block is another character-defining feature of this property type. There is an accentuated primary entry that generally features a recessed door. There are large display windows for merchandise, with kickplates or bulkheads below to protect the windows from the feet of passersby, and to form a sound base for the windows. There are transoms above the entry and display windows, extending the full width of the storefront. The transoms allow for additional light in the storefront, but were also often covered with awnings in order to control the amount of light. Usually a steel lintel was above the transoms, and a signboard area above that. Pilasters, often cast iron on late nineteenth century buildings, enframed the storefront and provided visual support for a storefront cornice, which separated the first from the upper stories.

Although the first story was open in order to provide a display for merchandise, the upper story walls were more solid. Depending on whether the building had frame or masonry construction, the upper stories were clad in either brick, stone, or wood siding. The second-story windows were tall and narrow, and more closely resembled those of residential buildings in that they were usually double-hung, rather than fixed panes of glass. These upper story windows tended to take their design cues from whatever was the popular style of residential architecture at the time; therefore the two-part commercial blocks employed a variety of fenestration openings in order to provide visual interest. While these were usually tall and narrow, they did vary in their shapes and sizes. Due the late Victorian era, they were frequently embellished by decorative surrounds or caps, and were sometimes set within arched, recessed openings. The second story windows were arranged in regularly-spaced patterns across the facade, although every window opening on one building was not necessarily identical. Combinations of paired and single windows were typical. Almost all two-part commercial block buildings had some form of elaboration at the cornice area.

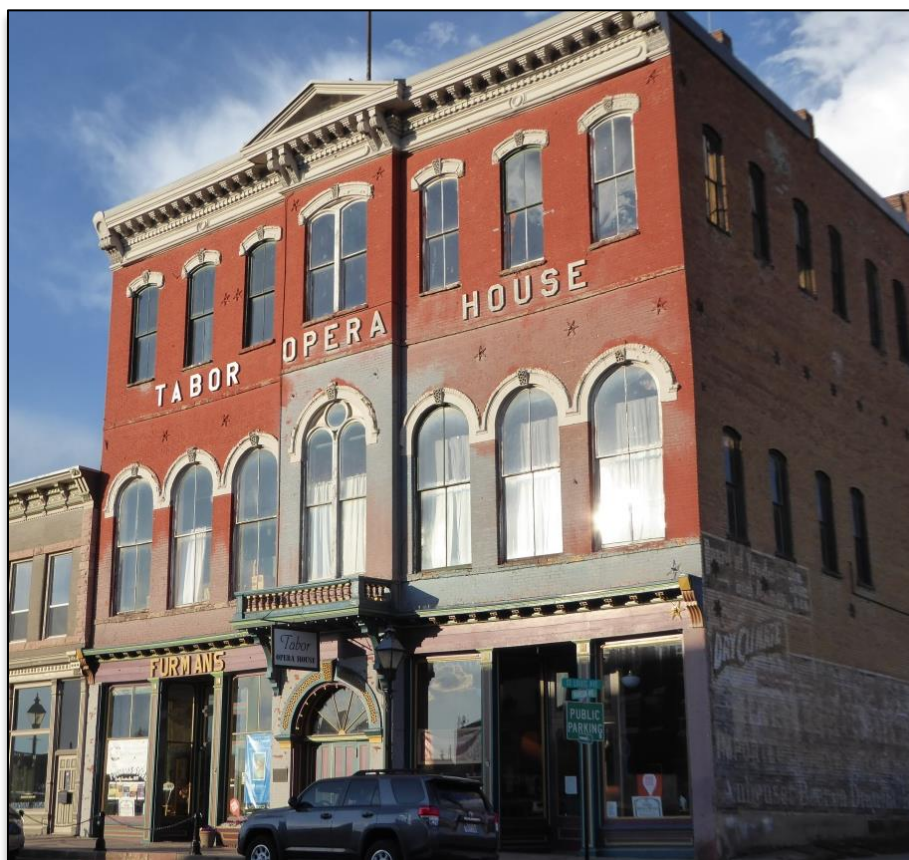
Like many Victorian styles, the Italianate emphasized vertical proportions and rich decorative details. In commercial buildings, it is characterized by wide overhanging, bracketed cornices, a variety of fenestration (usually very tall, narrow, 1/1, double-hung), and molded window surrounds. The development of cast iron and pressed metal in the nineteenth century allowed for economical mass production of decorative features for storefronts that merchants could not have afforded otherwise.⁴ Thus elaborate storefront columns and heavy bracketed cornices are found in this material in Italianate commercial buildings. Tall, narrow upper story windows with hood moldings and corner quoins are other typical features of this style. Buildings in this style also sometimes featured accentuated string courses, but were always defined by the wide cornices with large brackets. The Tabor Opera House at 308-312 Harrison (5LK.40.19) is the most significant example of the Italianate commercial style in Leadville, although several other buildings have a few elements of this style. The Opera House has a projecting center bay capped with a bracketed pediment rising above the cornice. There is a large, semi-circular transom window featuring radial muntins above the entry door; above is a semi-circular, decorative lacework cast concrete crown featuring a keystone. A second story balcony above the entry is supported by brackets and features stout carved balusters. Serving as an elaborate terminus to the building, the façade is crowned with an projecting cornice entablature with classical features such as oval panels, a dentil row, large scrolled brackets, and smaller flat brackets supporting the overhang.

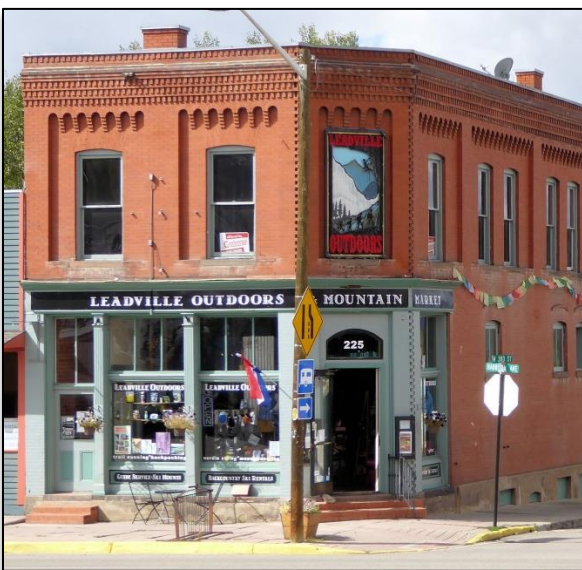
225 Harrison (5LK.40.1)

The extant commercial buildings from late nineteenth century that are not examples of the Italianate or Romanesque Revival styles tend to have less elaborate details, but nonetheless still indicate Victorian stylistic influences. Late Victorian commercial buildings may have brackets, parapets, finials, or simple parapet at the primary roofline. Windows are still tall and narrow, and may have less elaborate sills and lintels. There may be masonry details, such as raised courses, recessed window surrounds, or panels near the cornice area. Cast iron columns may be present on original storefronts. In the examples below, note the varying treatments of the second story windows and cornices.

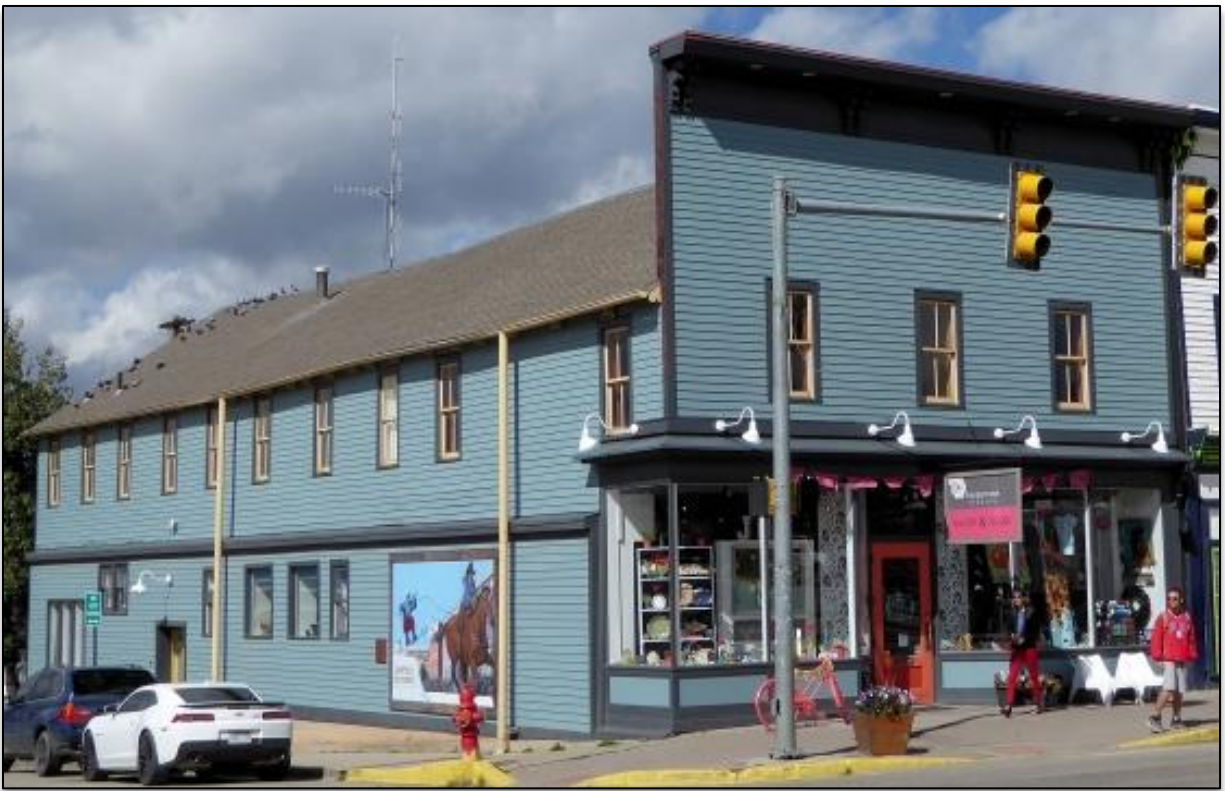
601 Harrison (5LK.40.6)

False front commercial buildings are iconic symbols of the pioneer west and mining towns in Colorado. Built of wood, their façade features a parapet with an elaborated cornice that extends above the roof line, these buildings were less expensive to construct than a brick commercial building. However, they presented a more impressive appearance than the simple wood structure at the rear. There is usually a storefront on the façade, with recessed entrance and large display windows. While these buildings were quite prevalent in Leadville during the late 1870s and 1880s, few remain today. The frame building at 601 Harrison, built in 1881, is one of the rare surviving examples of a false-front commercial building in Leadville. At one time, the town was filled with examples of this icon of the American West. They were typically among the first type of commercial buildings that were constructed, following the log cabin. In mining boom towns like Leadville, owners were reluctant to spend much money in the uncertain economy. These one story frame buildings were cheaper than masonry, but the false-front arrangement (a large front wall often rising to two stories in the front) presented a more impressive sight.¹⁰ The large front wall also provided a place for advertising, and the false cornice above made it appear more urban.

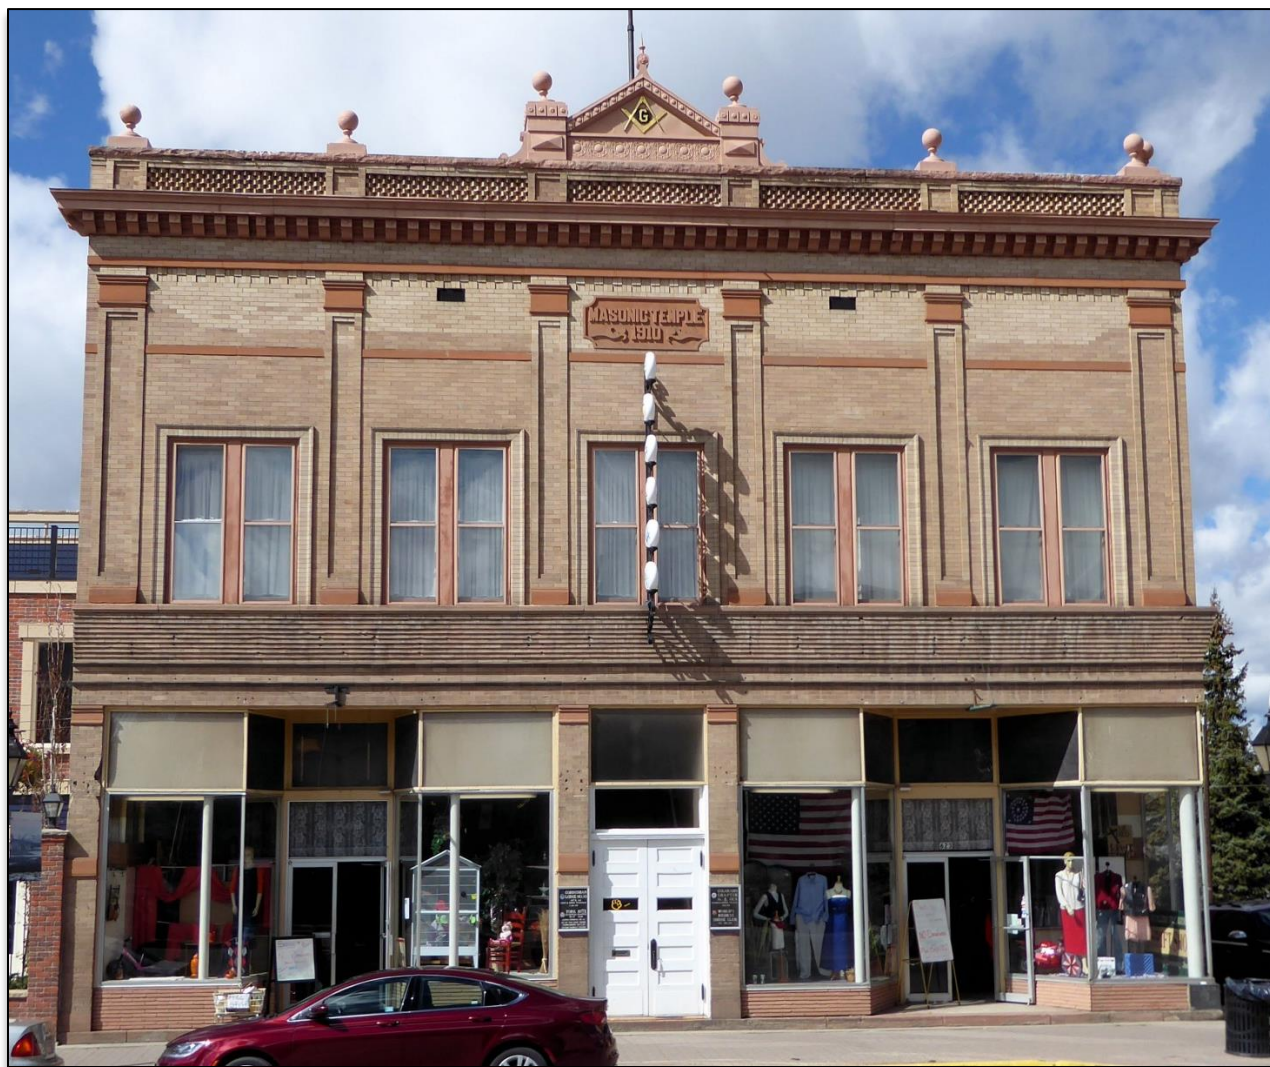
621-623 Harrison Avenue (5LK.40.12)

There are only a few examples of early twentieth century commercial buildings in Leadville; their forms are related to either the two-part commercial block (described earlier) or the one-part commercial block (on following page). The two-part commercial block example below retains the distinction between the lower and upper zones, with first floor storefronts featuring recessed entrances and display windows. However, this differs somewhat from the earlier counterparts by simpler or classically-inspired ornamentation, such as the engaged pilasters on the second story. The window surrounds are less elaborate, and the second-story cornice is the primary area of embellishment. Materials changed slightly, as there were often constructed of light colored brick instead of the red brick that was locally fired in the late nineteenth century.

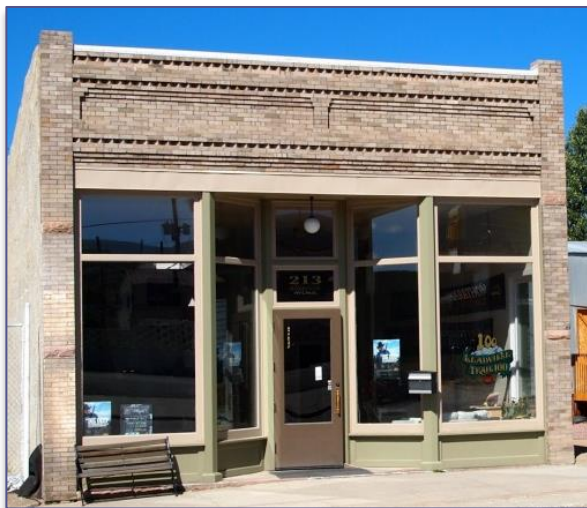
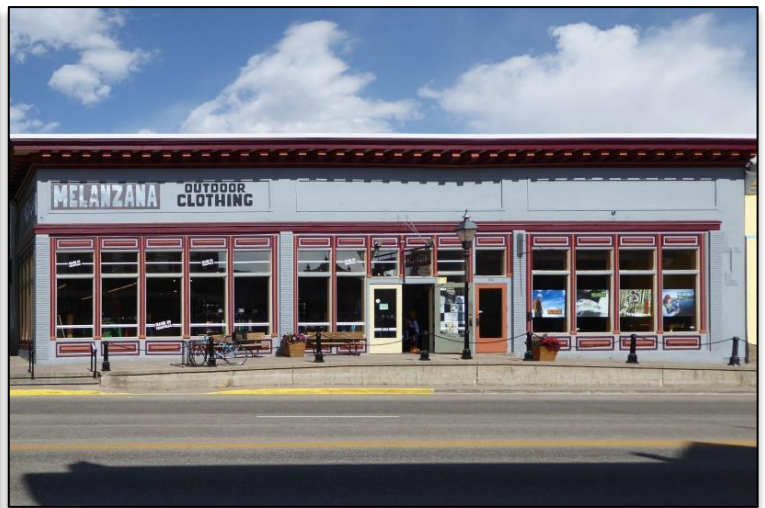
The storefront of 213 Harrison (left below, 5LK.40.58)) is primarily comprised of a large area of plate glass across the front, with little embellishment except for the cornice area. There is little historical references in the brick pattern work. The cornice of 714-716 Harrison (right, 5LK.40.36) on the other hand, harkens back to the Victorian era that preceded its construction.

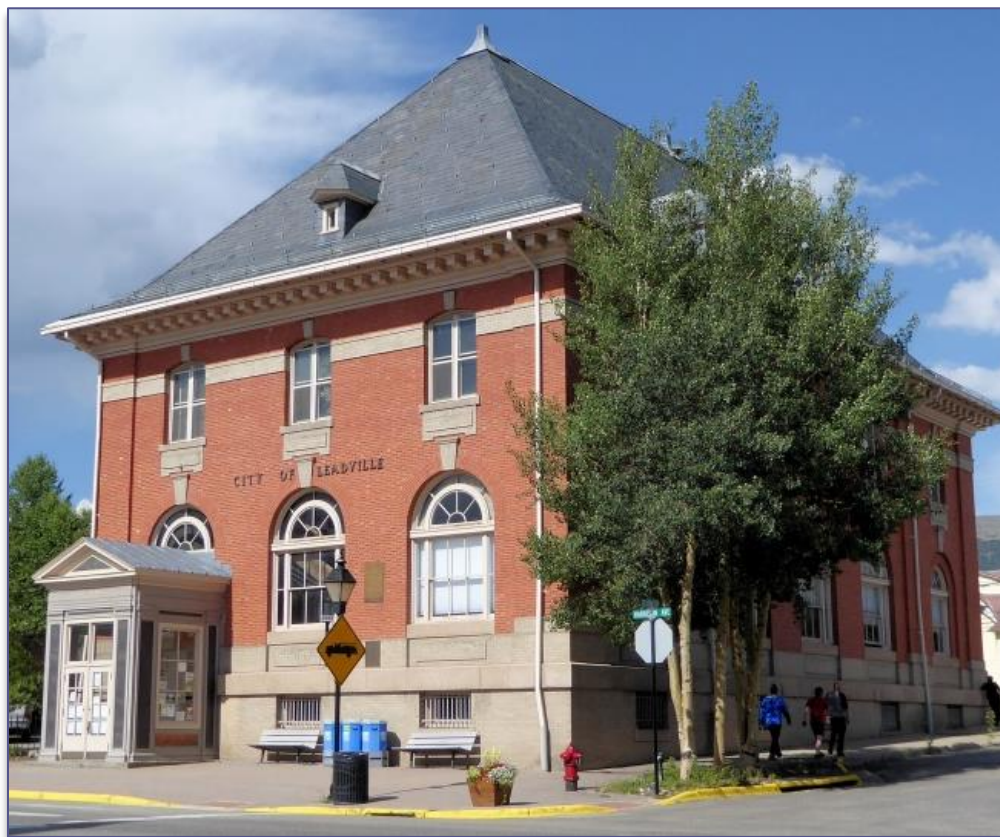
Leadville City Hall, 800 Harrison Avenue

There were two examples of this property type in this survey project: Leadville City Hall building and the Lake County Courthouse. Although few in number, their prominent location and design elements make these buildings important visual and historical landmarks in Leadville. These two buildings were of brick construction and were architect-designed; as such, they were both examples of a style prevalent during their period of construction. The Leadville City Hall (5LK.40.37) is a Classical Revival style building. It has a high, light tan brick foundation with a wide dressed-face stone sill separating the basement from the first story. The tan brick continues up to the bottom of the first story window sills, and is repeated as decorative panels beneath the second story windows, window keystone accents, and as a continuous lintel course connecting the second story window. The large first story windows are recessed, and set within a semi-circular comprised of a wide band of radiating brick voussoirs. The entry door has a semi-circular transom that is visible above an enclosed pedimented gable porch with classically inspired pilasters at the corners. The second story windows have semi-elliptical arched tops with a row of radiating brick voussoirs and tan brick stretchers forming keystones. The steeply pitched slate roof has flared eaves and an overhanging boxed cornice with flat bracket/modillions and a molded frieze board.

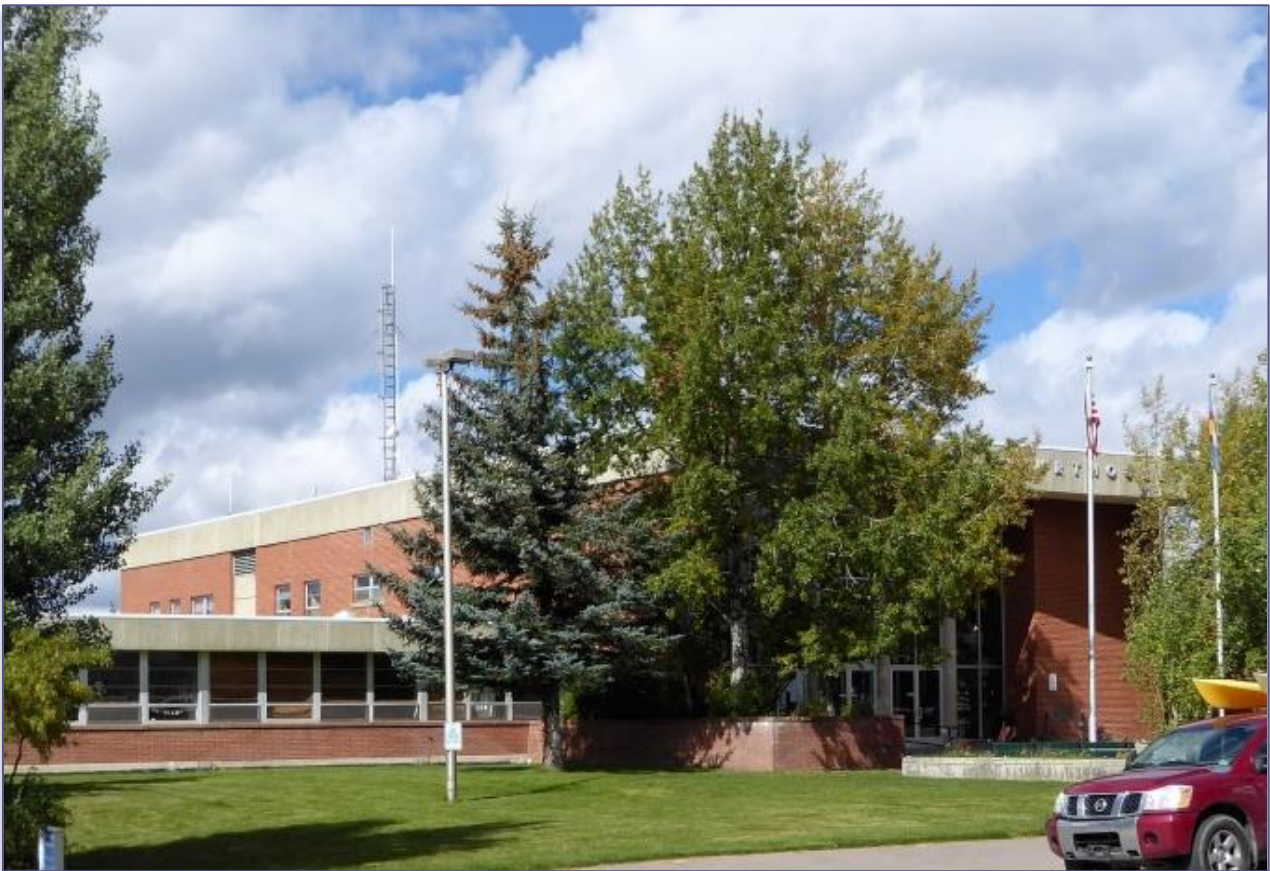
Lake County Courthouse, 505 Harrison Avenue

The Lake County Courthouse (5LK.40.67) is an International style building with a modified (offset) cross-plan. Typical of the International style, the building has smooth, unornamented surface, a flat roof, and bands of windows. There is also a wide concrete band on the cornices of both the central block and wings; this concrete band extends forward to form an overhang. The central block's overhang is supported by a brick curtain wall on the south and four unadorned concrete columns near the entry, but the north end of the overhang is cantilevered. At either end of the two wings, the overhang is supported by a brick curtain wall. The southern 2/3's of the central block has a window wall with metal mullions forming a grid pattern; there are two paired entry doors set within the glass fenestration pattern.

The south wing has a row of windows with four horizontal sashes divided by wide mullions; the lower sashes are hinged. Beneath the windows is a continuous brick sill course. These elements (concrete cornice, band of windows, brick sills), combined with a concrete foundation sill, emphasize the horizontal lines of the building. The shorter north wing has a band of high clerestory-like windows beneath the concrete coping. The end walls (north & south) of both wings are solid brick.

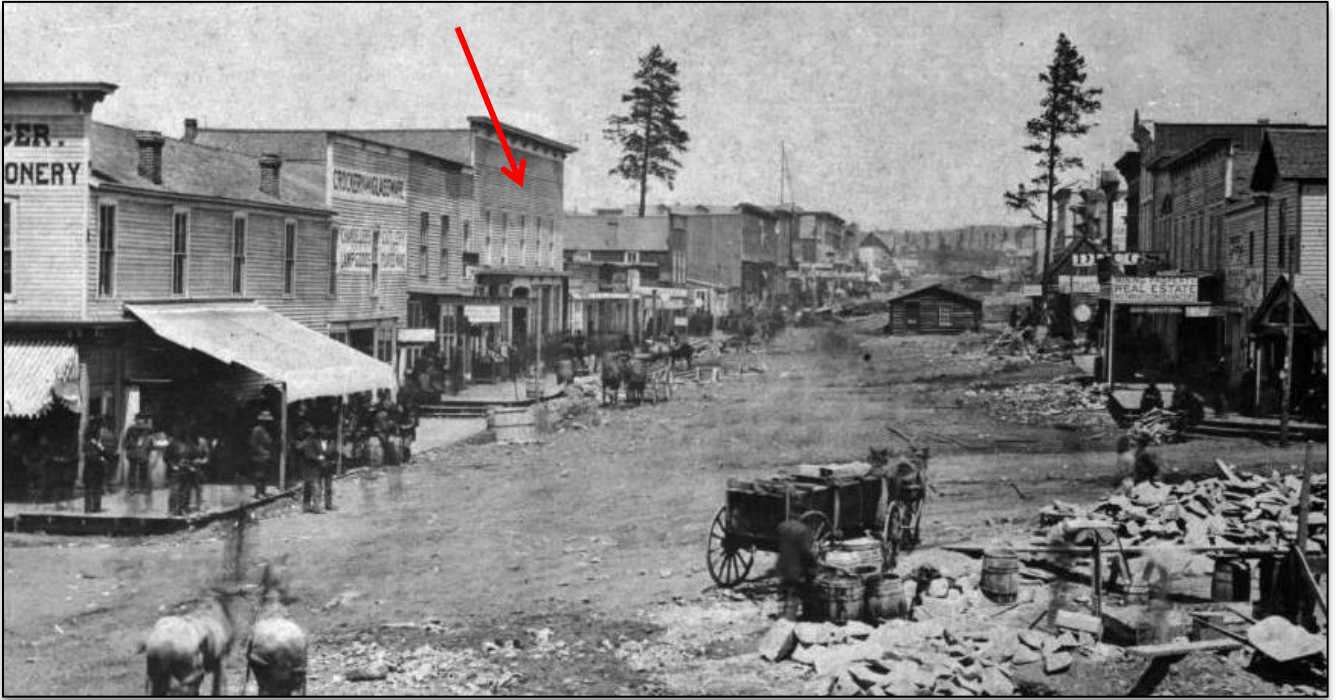
1879. Source: CHS.X4631/X-444, Denver Public Library online digital photo collection.

All of the earliest commercial construction along Harrison Avenue was wood. Some of these were log cabins, simple frame false-front buildings, or residential buildings converted to commercial use. Three views below of the same stretch of Harrison Avenue, looking north from Chestnut Street, show how quickly the street evolved once commercial growth moved onto Harrison. For reference, an arrow points to the same building in each view.

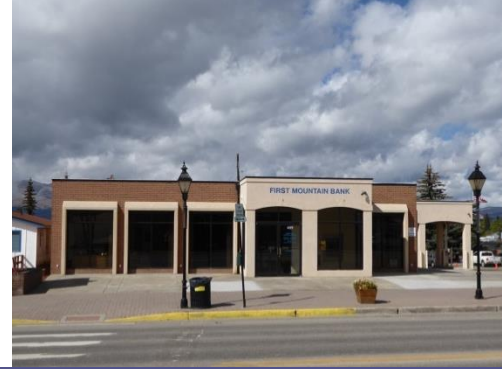
<p>5LK.40.130</p>	<p>409 Harrison Ave.</p>	<p>Built 1966. Does not date from likely period of significance for NRHP historic district. Enclosed front entry bay does not date from original construction, thus impacting integrity.</p>

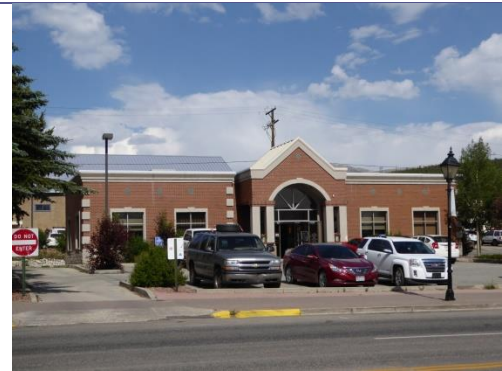
<p>5LK.40.131</p>	<p>600 Harrison Ave.</p>	<p>Built 1996. Does not date from likely period of significance for NRHP historic district. Retains integrity from 1996 construction date.</p>
