Table 1. Leadville Historic Resources Survey: Phase 1 – Intensive-level survey

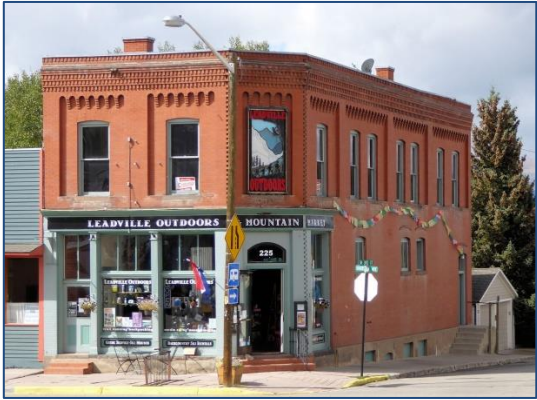
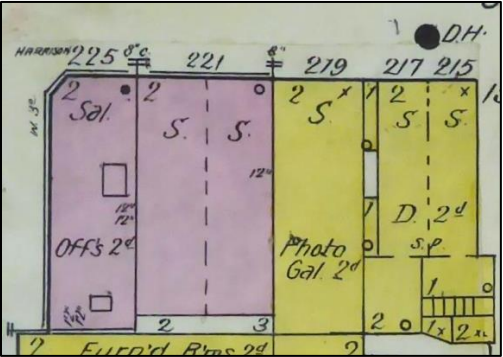
5LK.40.1	225 Harrison Ave.	Ca. 1895 Anheuser-Busch Building	Yes	Yes	The building retains a very high degree of integrity in all aspects, particularly design and materials. Photographs from the 1890s indicate that the building's storefront was never greatly altered over the years. Would be individually eligible, as well as a contributing building to the NHL district.

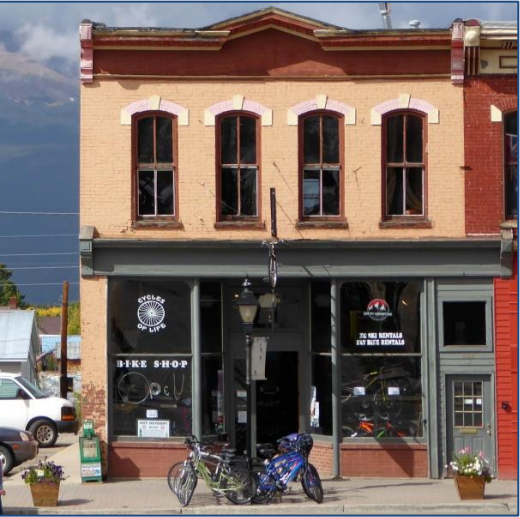
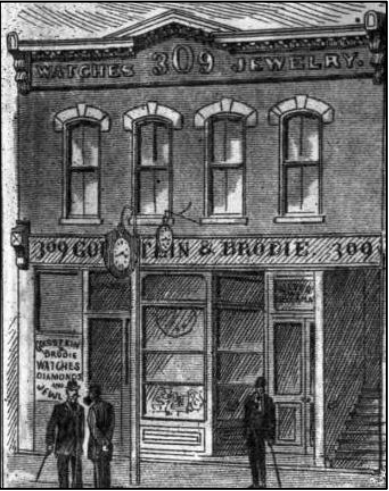
5LK.40.2	309 Harrison Ave.	1878 Bush-Trimble Block; Goldstein & Brodie Jewelers; Joslin & Park Jewelers	Yes	Yes	Although the storefront installed in 2004 is compatible with the original design, the configuration of the storefront has been modified—the number of entries changed from two to one. Due to this change, the building's significance under Criterion C has been compromised. However, the second story retains integrity from its period of construction and the building retains enough overall integrity to be considered individually eligible under Criterion A for Commerce and a contributing resource to the NHL district.

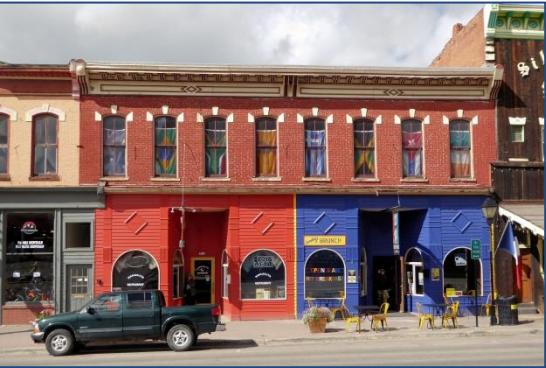
5LK.40.3	311-313 Harrison Ave.	1878 Bush-Trimble Block	No	No	The altered storefronts have a negative impact on both individual eligibility and the building's ability to contribute to the NHL district.

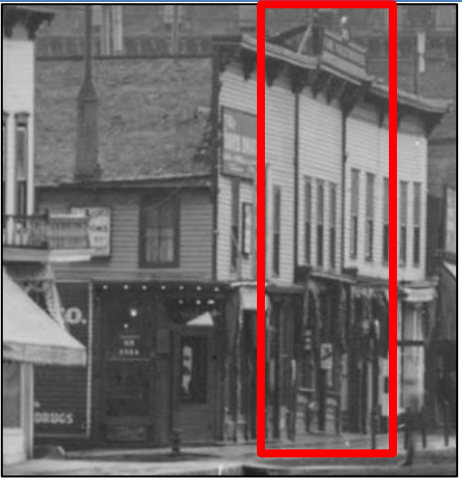
5LK.40.6	601 Harrison Ave.	1881 Avenue Wine & Billiard Hall	No	No	A survey conducted in 1981 concluded that alterations rendered it non-contributing to the district. Recent rehabilitation efforts have restored some of the building's earlier features including the appearance of horizontal wood siding, decorative cornice and three façade windows. However, other elements from different historical periods result in features that never existed together historically, including the first floor windows on the south. It would not be individually eligible for the National Register of Historic Places or contributing to the NHL district.	  Between 1890 & 1893
 	5LK.40.7	603 Harrison Ave.	Ca. 1881 The White House	No	Yes	A 1981 survey noted the slightly altered entry, but concluded that this was a rare and relatively intact frame commercial building. It retains its original windows and cornice, and the replacement siding closely matches the original. However, an 1887 illustration that appeared in a Leadville newspaper showed a large arched signboard over the cornice; a slightly different signboard is seen in the photo on the right. It would be considered a contributing building to the district; a search for clearer historic photographs may provide more detail on the original storefront.

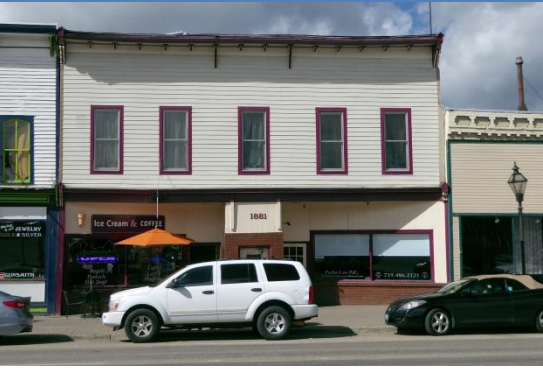
5LK.40.8	605-607 Harrison Ave.	Ca. 1881	No	No	A survey conducted in 1981 noted the non-compatible storefront. Additional changes to the windows, in addition to the mid-twentieth century storefront, make this a non-contributing building to the district.	  1920
 	5LK.40.9	609 Harrison Ave.	Ca. 1880 O. R. Fluke, grocery	No	No	A survey conducted in 1981 noted that while the pigmented glass storefront was not contemporaneous with the period of significance, it was a good example of ca. 1930s architectural trends. Since that time, however, it has undergone at least two more façade alterations. The current iteration, where the majority of brick cladding is covered with siding, combined with the ca. 1930s storefront alterations, make this a non-contributing building to the NHL district.	  1887 newspaper illustration

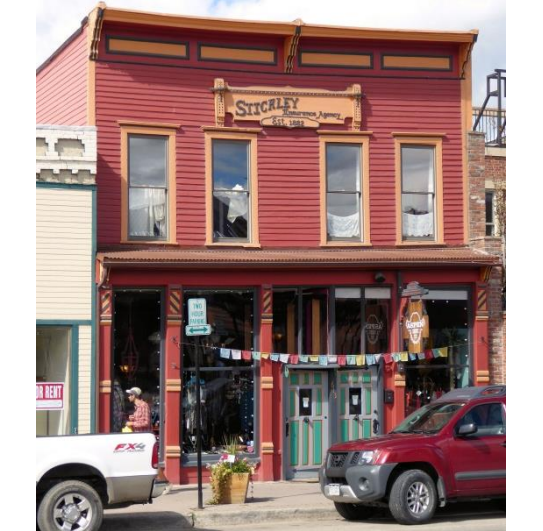
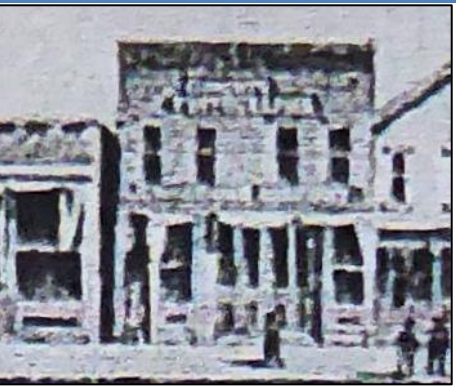
5LK.40.10	613 Harrison Ave.	Ca. 1880 Stickley building	Yes	Yes	This building is one of the most intact frame commercial buildings on Harrison Avenue. and exhibits a high degree of integrity on the façade, both at the storefront and second stories.

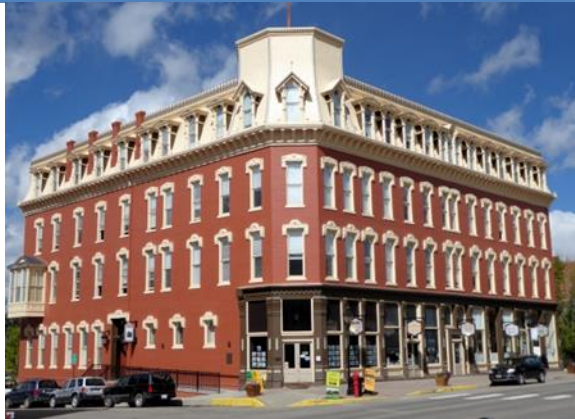
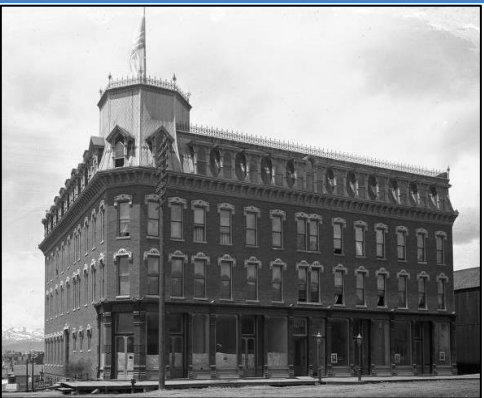
5LK.40.13	701 Harrison Ave.	1883-1885 Tabor Grand Hotel Kitchen Hotel Vendome Hotel	Yes	Yes	This building retains a high degree of integrity on the exterior. The key character-defining exterior features of George E. King's Second Empire design were kept intact in the two recent rehabilitation projects. The porticos, added ca. 1889 and removed in the 1950s, were not part of King's original design for the building.

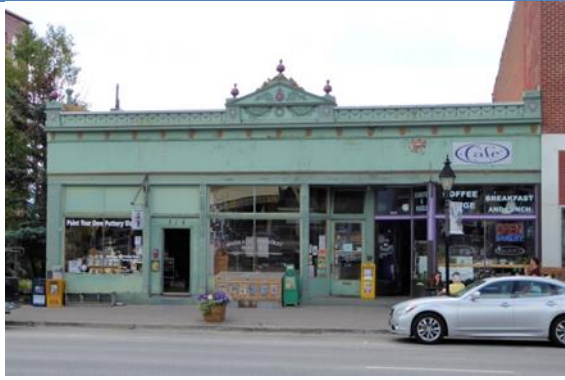
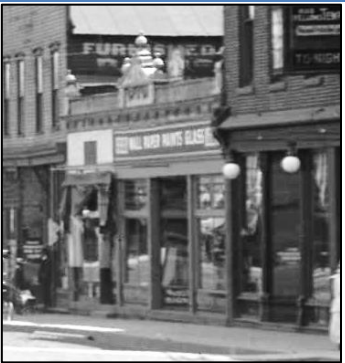
5LK.40.14	715-717 Harrison Ave.	Ca. 1895 Kostitch Block (new)	Yes	Yes	This building retains a high degree of integrity on the exterior, retaining most of its design and materials from its period of significance, with the exception of one door opening and likely the kickplates beneath the display windows. The key character-defining features of the Late Victorian style are present, and the underlying form of the building is also retained.

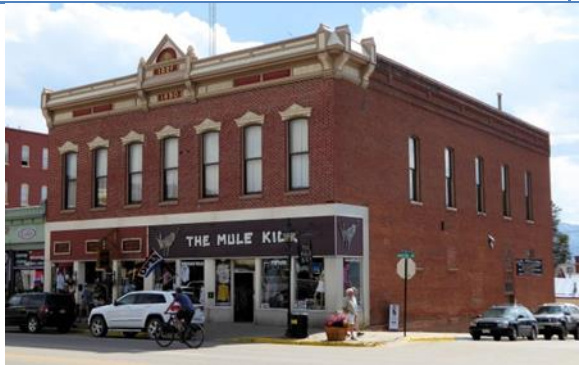
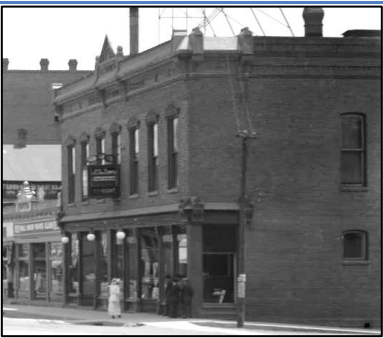
5LK.40.15	719-721 Harrison Ave.	1890 I.O.O.F. Hall building	Yes	No	This building retains a high degree of integrity on the second floor façade and other elevations. The storefront alterations, likely dating from the mid-twentieth century, affect the building's integrity in the area of architectural significance since the NHL requires a higher degree of integrity.

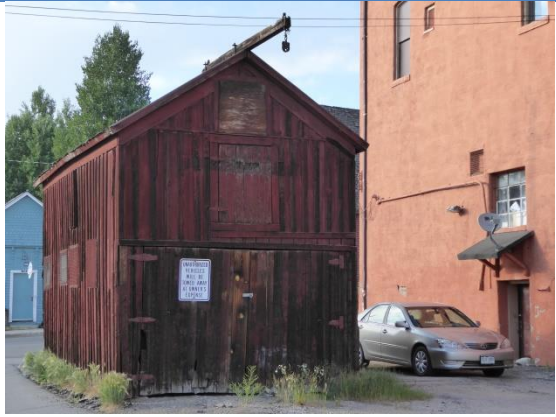
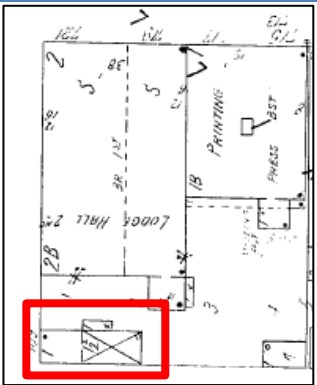
5LK.40.15	719-721 Harrison Ave.	Between 1895 & 1937 I.O.O.F. Hall - outbuilding	No	Need data	Further research is needed for the date of the frame barn/garage, as it is unknown if it was built during the NHL district's period of significance (1860-1900). If so, the barn retains enough integrity to also be considered contributing to the district.

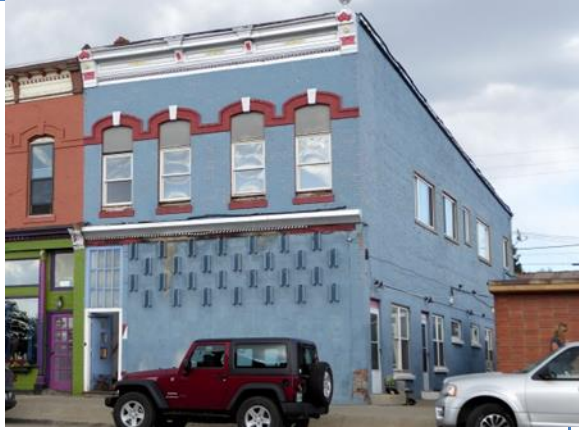
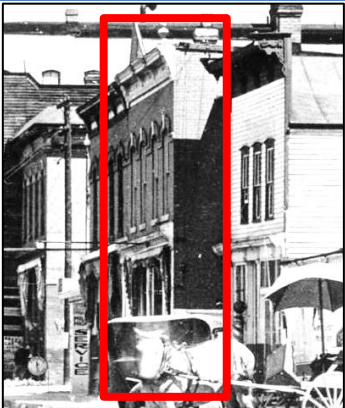
5LK.40.17	220 Harrison Ave.	Ca. 1893 Western Policy Association building Silver State Restaurant	No	No	The storefront alterations that occurred after the district's period of significance have negatively impacted the building's integrity to such a degree that it would not be considered a contributing resource in the NHL district.

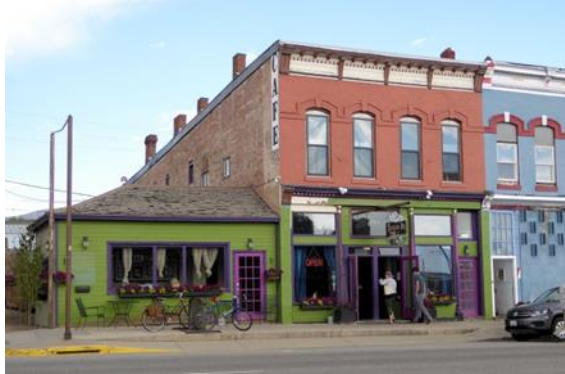
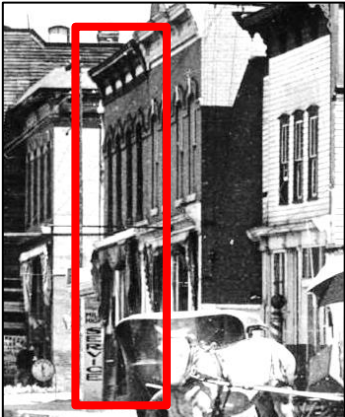
5LK.40.18	222 Harrison Ave.	Ca. 1893	No	No	The storefront alterations have a negative impact on the building's integrity since the NHL requires a higher level to be retained.

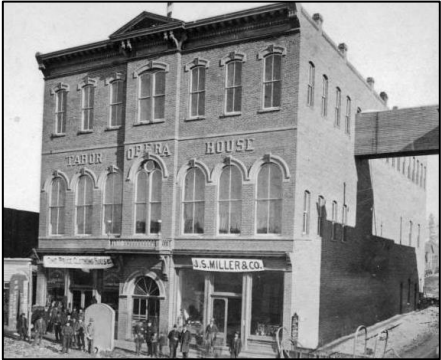
Late 1879 or early 1880

27 July 1924
 	5LK.40.19	308-312 Harrison Ave.	1879 Tabor Opera House	Yes	Yes	Except for the rear addition and some door replacements on the south side, the building's exterior is virtually unchanged since its construction. According to the 2003 Historic Structures Assessment report, the interior is relatively unchanged from the 1901 remodeling undertaken by the Elks. This remodel reflects the changing fortunes of Leadville after the decline of its silver mining economy.

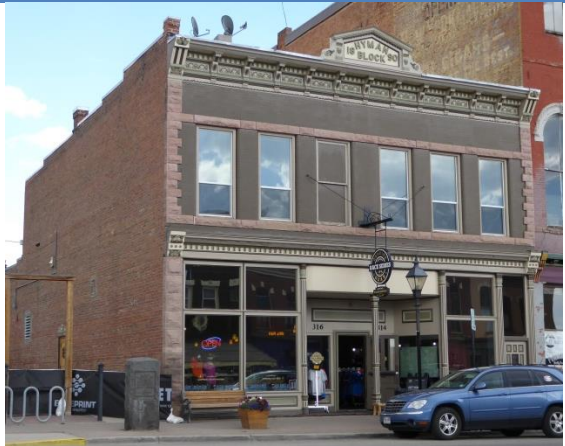
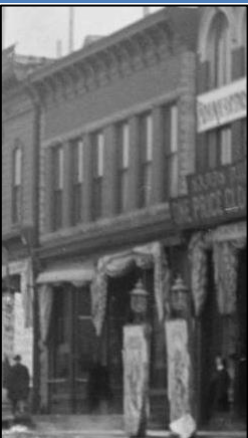
5LK.40.20	316 Harrison Ave.	1890 Hyman Block	Yes	Yes	The storefront, reconstructed in the late 1980s, is compatible with the original design of the building and maintains the original storefront configuration as evidenced by historical photos. Original cast-iron pilasters around the south door are distinguished from the newer replacements at the recessed entry. The second story windows are not original and differ in material and design from the historic 1/1 double-hung windows. The changes to the second story windows, coupled with the late 1980s alterations to the storefront, compromise the building's significance under Criterion C. However, key character-defining façade features are intact: the stone quoins, sill and lintel bands, the highly elaborate cornice bands, supporting individual eligibility under Criterion A.

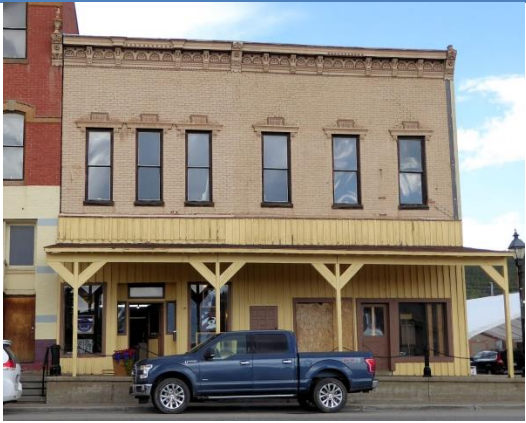
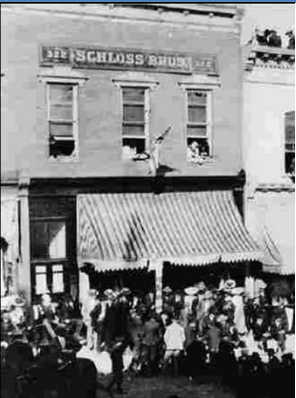
5LK.40.21	322-324 Harrison Ave.	1889 Miller-Schloss Building	No	No	The alteration of the building’s storefront, along with the addition of a full-width front porch, negatively impact the building’s individual eligibility and its contributing status for the NHL district.

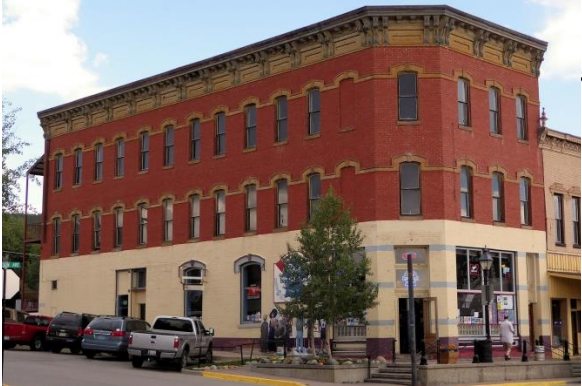
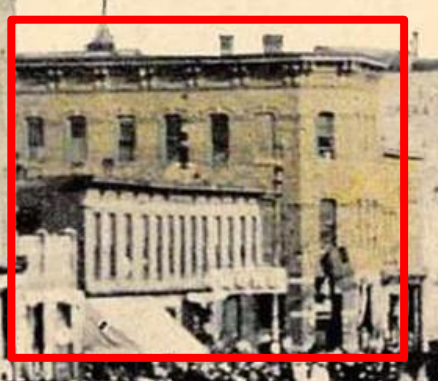
5LK.40.22	326 Harrison Ave.	1887 Breene Block	Yes	Yes	The replacement display windows match the historic windows in size but differ in design and material and the closed-down storefront on the east end of the north wall is not compatible with the original character of the building. These changes may weaken individual eligibility under Criterion C. However, the intact second and third story windows and the wide, overhanging metal cornice are key character-defining features and the building retains enough integrity for individual designation under Criterion A.

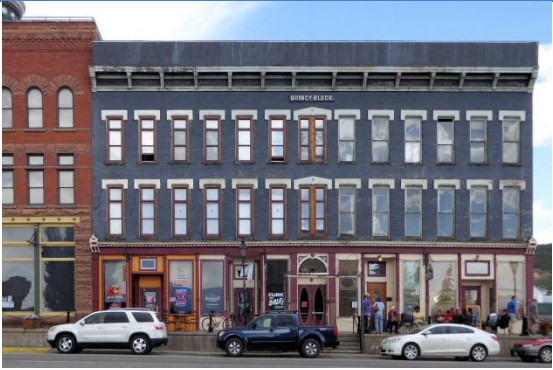
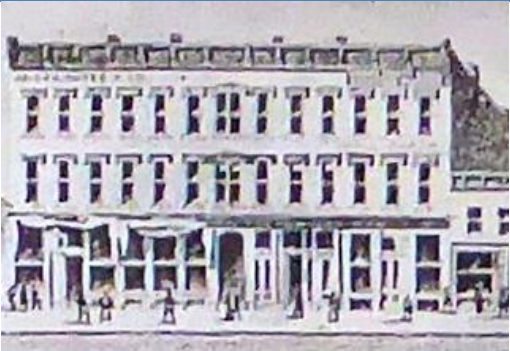
5LK.40.23	414-420 Harrison Ave.	1880 Quincy Block	No	No	A review of historic photographs show that the following alterations have occurred to the facade: 2 nd & 3 rd story façade windows have been replaced and have a different design from the original; the storefront alterations are recent; and the cornice has been covered. Although this occurred early in the twentieth century, further examination is recommended to see if the original cornice is extant beneath the simple metal sheathing.

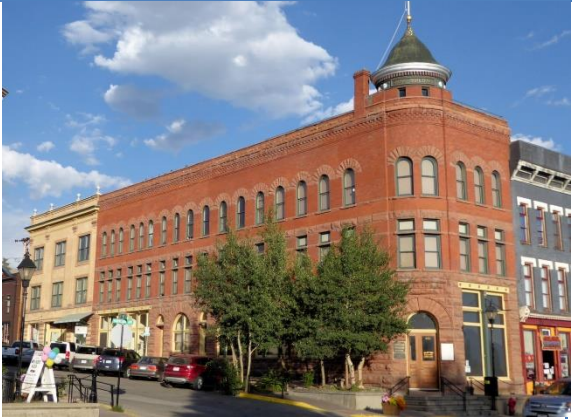
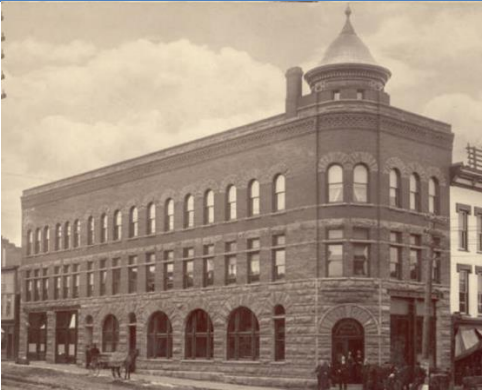
5LK.40.24	460 Harrison Ave.	1891-1892 American National Bank Building	Yes	Yes	A review of historic photographs show that the two public elevations – Harrison Avenue and E. Fifth Street – retain a very high degree of integrity and is individually eligible for the National Register. The only significant alteration is a missing arched pediment above the cornice on the Bank Annex building

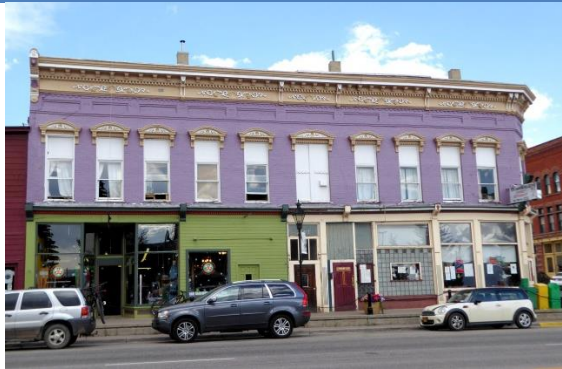
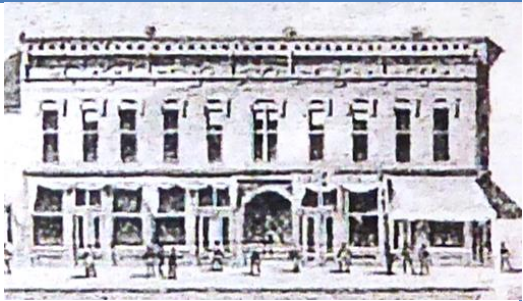
5LK.40.25	500-502 Harrison Ave.	1880 Howell Block; Emmet Block	No	No	A review of historic photographs show that the Harrison Avenue elevation retains a fair degree of integrity, particularly on the second story. The two north storefronts are not original and detract from integrity of design and materials. With restoration of the Harrison Avenue storefronts and second story windows, the building may be individually eligible for the National Register and/or contribute to the NHL district.

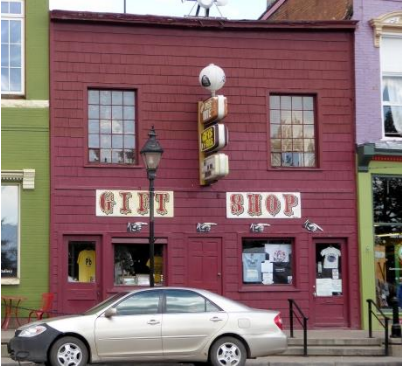
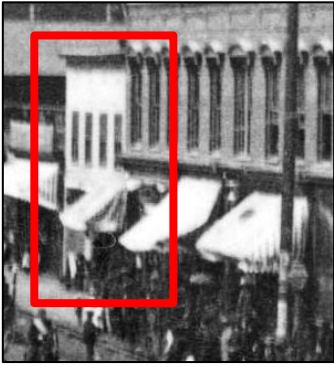
5LK.40.26	506 Harrison Ave.	Ca. 1879	Yes	No	Significant changes to the façade occurred ca. 1930s compromising the building's architectural significance, however, the building retains sufficient integrity from the 1930s to be individually eligible under Criterion A for Commerce for that period.

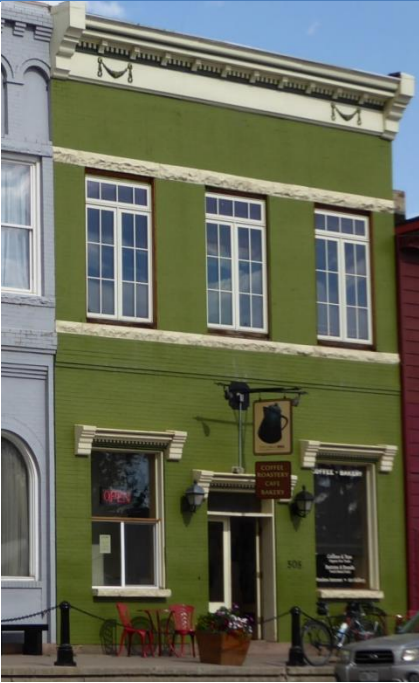
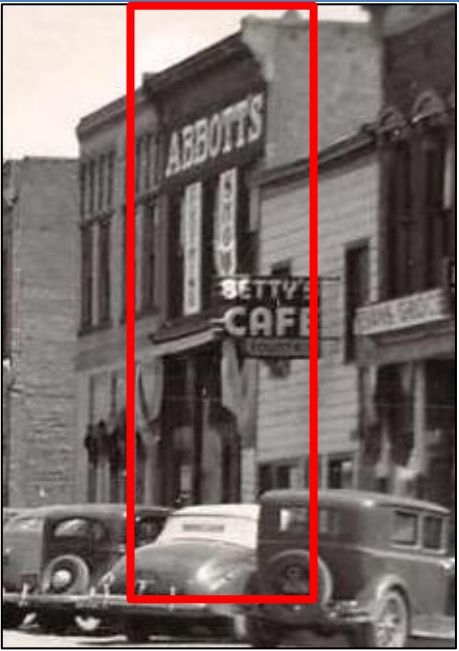
5LK.40.27	508 Harrison Ave.	Between 1889 & 1895 Hoffman's Toggery	No	No	The alteration of the building's storefront, along with the non-historic upper story windows, negatively impact the building's individual eligibility for the National Register and contributing status to the NHL district.

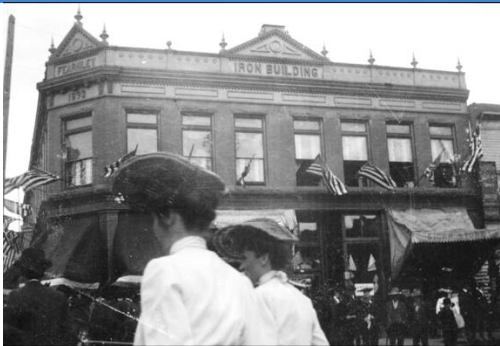
<p>Ca. 1930s-1940s</p>
 	5LK.40.29	516-522 Harrison Ave.	1893 Fearnley Block/Iron Building	Yes	Yes	The Iron Building retains a very high degree of integrity on the exterior, with minor alterations including some window replacement and transom coverings. However, the transom divisions are still clearly evident, and the key character-defining late Victorian era commercial design elements result in a building that is individually eligible as well as being contributing to the NHL district.

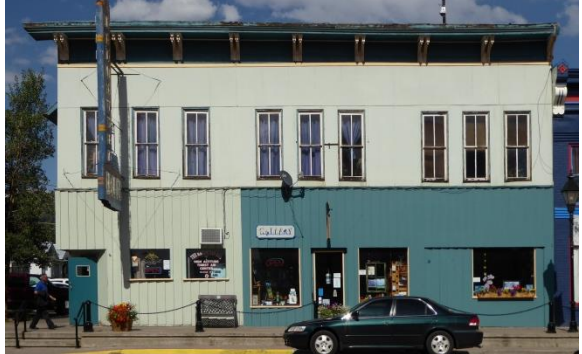
<p>Between 1900 & 1910</p>
 	5LK.40.30	612 Harrison Ave.	Ca. 1882	No	No	Extensive alterations to the façade occurred after the NHL's presumed period of significance and include new brick cladding, as well as changing the storefront elements.	  <p>1915</p>

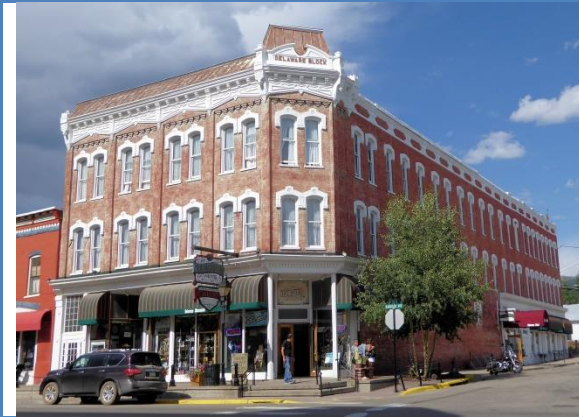
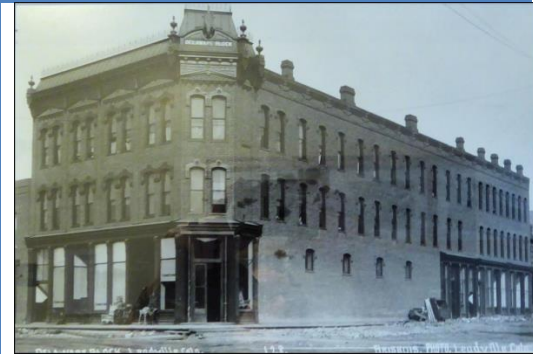
5LK.40.32	700 Harrison Ave.	1886 Delaware Block Building; Delaware Hotel; Crews-Beggs Dry Goods Co.	Yes	Yes	The building is little altered on the exterior, and retains all of its key character-defining features, such as the segmentally arched windows with decorative label surrounds, the highly elaborate cornice, storefront delineations, and mansard roof.

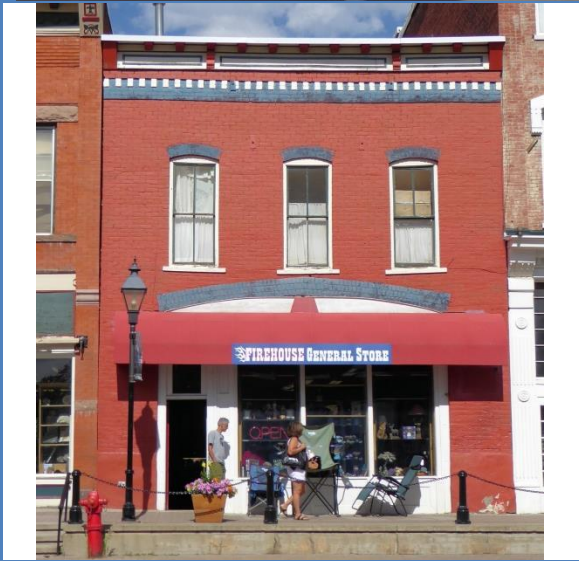
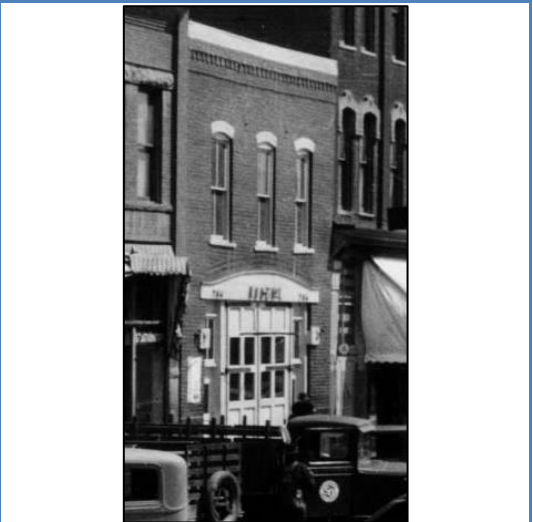
5LK.40.33	704 Harrison Ave.	1882 Hose Co. #3; Hook & Ladder #1; City Fire Department	No	Yes	Removal of the original vehicle doors on the first floor has compromised the building's architectural significance and its individual eligibility. However, the new storefront is set within the original opening and the original elements on the second story remain intact suggesting that the building retains sufficient integrity for to be considered a contributing resource to the NHL district.

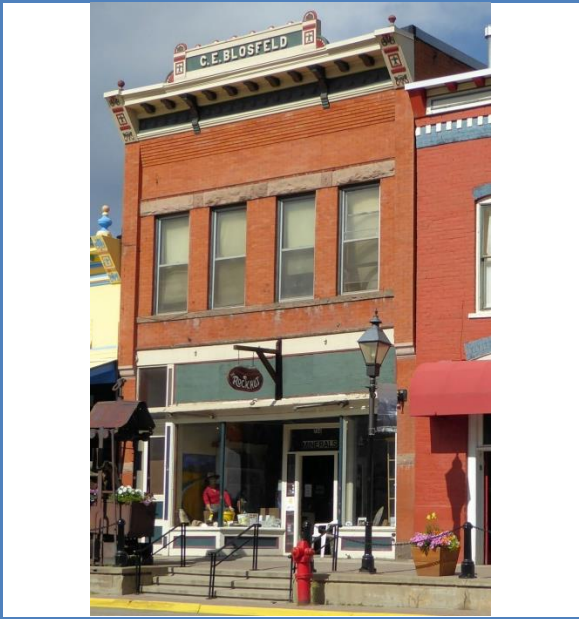
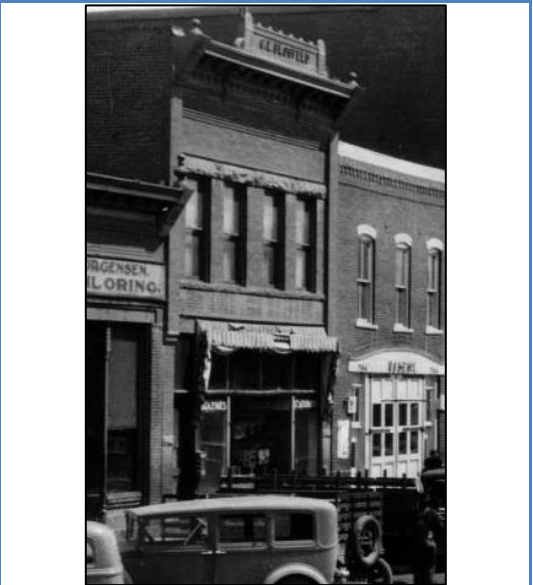
5LK.40.34	706 Harrison Ave.	1901 Blossfeld Block; YMCA	Yes	No	The Blossfeld Block building is little altered on the exterior. The storefront transom area is closed down with plywood, but the key storefront elements are clearly evident: recessed entry, display windows, kickplate, and transom. The decorative cornice is also unchanged. This building is individually eligible, but due to the NHL's presumed period of significance, would not be a contributing resource to the NHL district.

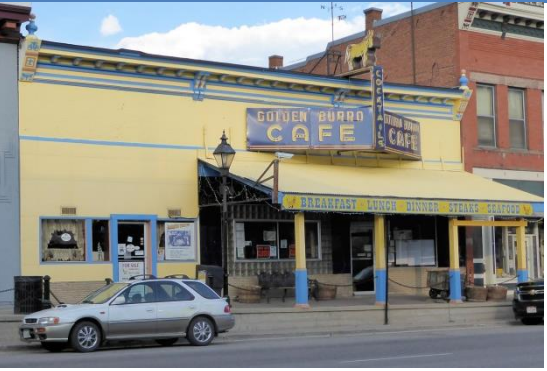
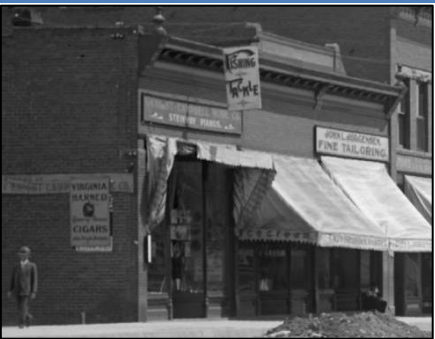
5LK.40.35	710 Harrison Ave.	Ca. between 1894 & 1898 Leadville Daily Miner	No	No	The building at 710 Harrison Avenue is an altered example of a “one-part commercial block” building. Since the focus of these buildings lies within the storefront, alterations in this area have a greater impact than on two-story buildings. In spite of retaining part of its decorative cornice (although a decorative pediment was removed), the storefront alterations along with the non-historic porch, would make this building non-contributing to the NHL district.

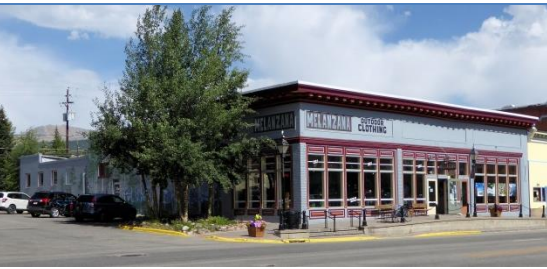
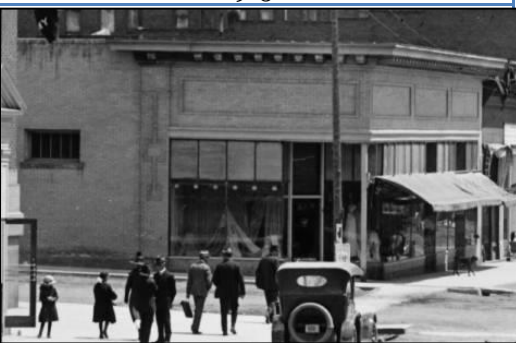
5LK.40.36	714-716 Harrison Ave.	Ca. 1917 – 1919 Hart-Zaitz Mercantile; Zaitz Mercantile; Ben Franklin	No	No	This is an altered example of an early 20 th century “one-part commercial block” building. As the focus of these buildings lies within the storefront, it is important that these buildings retain elements that define this feature. The storefront was extensively modified sometime between 1937 and 1981 and additional alterations to the doors and windows made more recently, thus compromising the building’s individual eligibility. It is not contributing to the district due to its construction date.

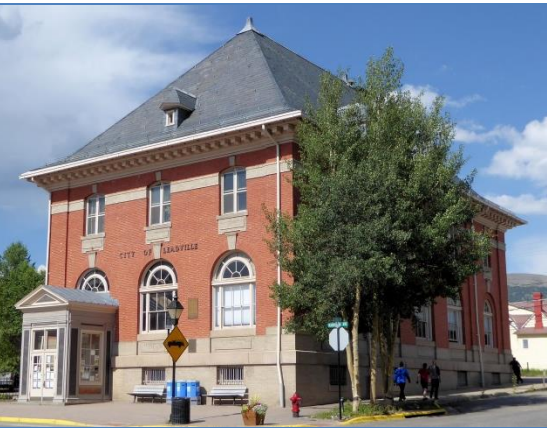
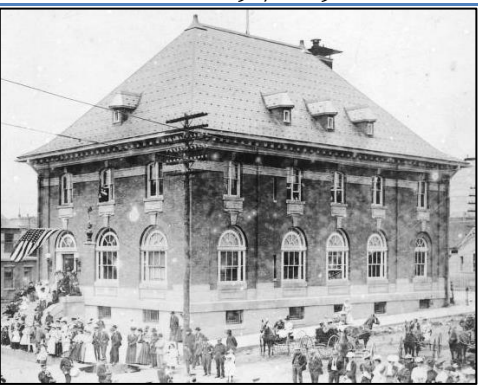
5LK.40.37	800 Harrison Ave.	1904-1905 Leadville Federal Building; Leadville Post Office	Yes	No	The Leadville Federal Building retains a high degree of integrity in all areas on the exterior. The alteration of the entry door to include a covered porch occurred prior to 1917, and was undoubtedly a belated realization of the extreme winter weather conditions in Leadville. The building also retains a high degree of interior integrity as well, retaining the original post office windows, room divisions, and interior finishes. Due to its construction date and the current implied Period of Significance, it would not contribute to the NHL district.

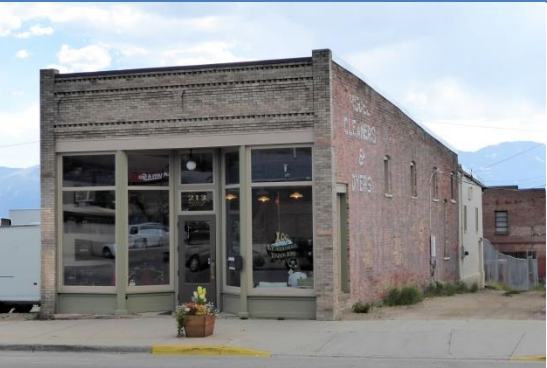
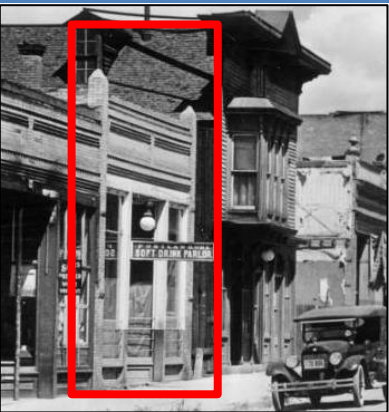
5LK.40.58	213 Harrison Av.	1908 Jos. Harwitz Building	Yes	No	The alterations to the building’s façade in the late 20 th century were remediated in a storefront rehabilitation in the early 21 st century. The current storefront is closely modeled after the 1920s appearance. The rear addition is later, but does not detract from the building’s integrity. Due to its construction date, however, it would not be considered a contributing resource to the district.

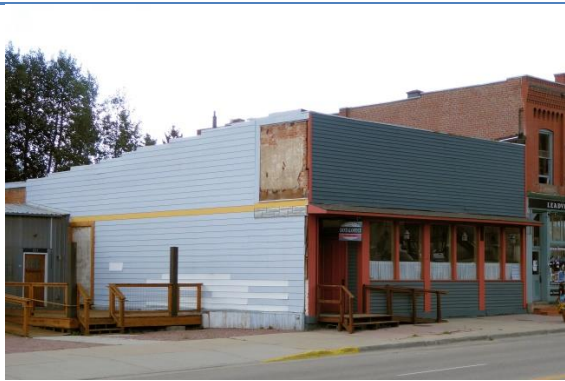
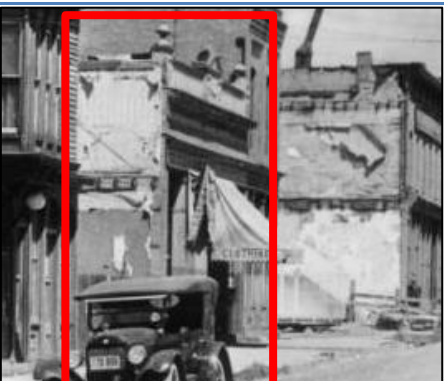
5LK.40.62	223 Harrison Av.	Ca. 1914	No	No	The alterations to the building's façade in the late 20 th century have resulted in a loss of integrity in design, materials, association and feeling. It would be considered a non-contributing resource to the district.

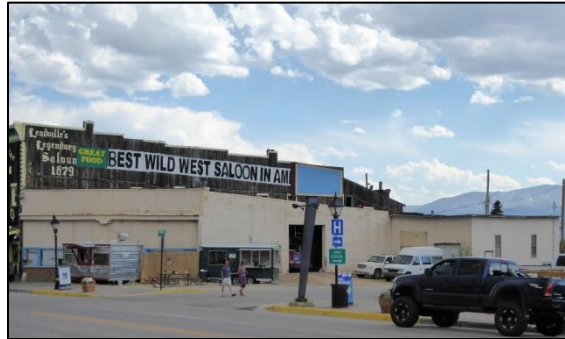
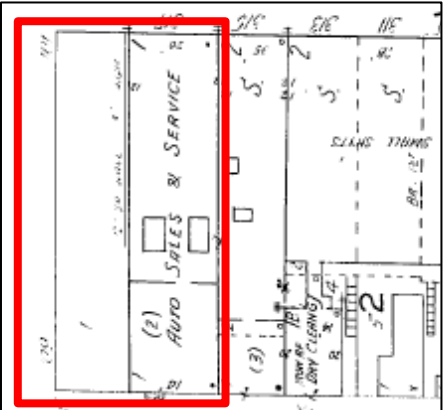
5LK.40.66	317 Harrison Ave.	Ca. 1936 Alderson Motor Co. Leadville Oil Co. Sixty-Six Service Station	No	No	The alterations to the building's façade (from parallel to Harrison to a 45° angle to the street – see Sanborn Map on right) and the closing down of the entry door) negatively impact this building's original design.

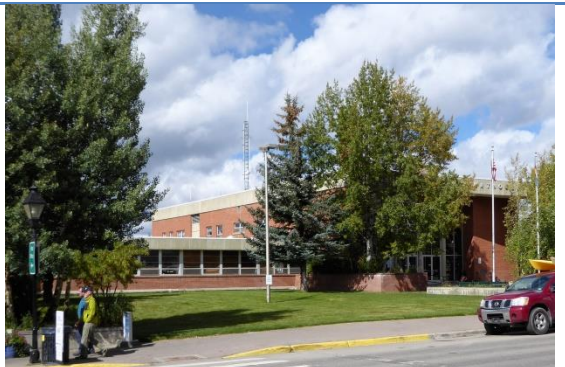
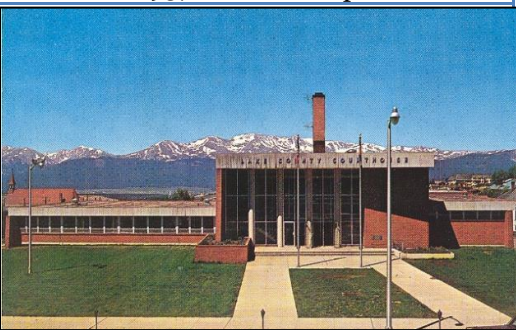
5LK.40.67	505 Harrison Ave.	1955 Lake County Courthouse	Yes	No	The Lake County Courthouse has retained a very high degree of exterior integrity that supports individual eligibility for the National Register. However, it was constructed after the end of the period of significance for the district and would not be a contributing resource to the NHL district.

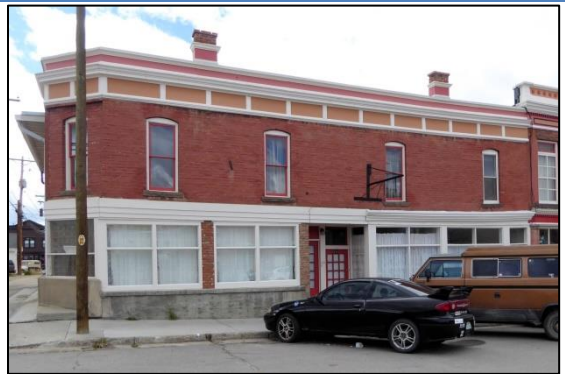
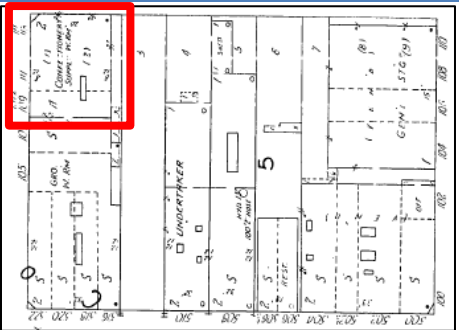
5LK.40.122	105-113 E. Sixth St.	1902 Iron Building Annex	Yes	No	The Iron Building appears to retain integrity of exterior design though no historical photos of the building were available for comparison. Likely minor changes included storefront window replacement and new entry doors. The building still retains display windows and transom distinctions and retains sufficient integrity for individual eligibility under Criterion A, but is not contributing to the district due to its construction date.
